Rock Slope Stability Assessment Using Slope Mass Rating (SMR) Method: Gunung Lang Ipoh Malaysia

Goh Thian Lai¹*, Ainul Mardhiyah Mohd Razib¹, Nur Amanina Mazlan¹, Abdul Ghani Rafek², Nur Ailie Sofyaiana Serasa³, Tuan Rusli Mohamed⁴

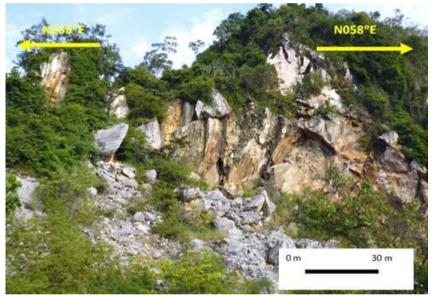
Fig-3: Slope of GL1, Gunung Lang, Ipoh, Perak

total rating $RMR_{\rm b}$ for slope of GL1, GL2 and GL3 were 77, 77 and 82.

Parameter	Value	Rating
Uniaxial compressive strength, UCS	53.6 -83.4 MPa	7
Rock Quality designation, RQD	97 %	20
Spacing of discontinuities	0.34 m	10
Condition of discontinuities	Discontinuities length 1-3 m, separation 0.1 - 1.0 mm, rough, no infilling, unweathered	25
Ground water condition	Completely dry	15
RMR _b		77

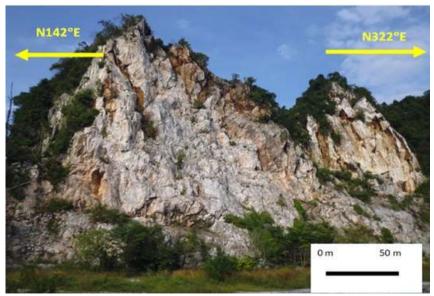
Fig-4: Slope of GL2, Gunung Lang, Ipoh, Perak

able 5. Result of assessment of Rolling	b for slope of OL2, Outling Lung, Ipon, I era	n, maiaysic	
Parameter	Value	Rating	
Uniaxial compressive strength, UCS	53.6 -83.4 MPa	7	
Rock Quality designation, RQD	98 %	20	
Spacing of discontinuities	0.47 m	10	
Condition of discontinuities	Discontinuities length 1-3 m, separation 0.1	25	
Condition of discontinuities	-1.0 mm, rough, no infilling, unweathered	23	
Ground water condition	Completely dry	15	
RMR _b		77

Table 3: Result of assessment of RMR_b for slope of GL2, Gunung Lang, Ipoh, Perak, Malaysia

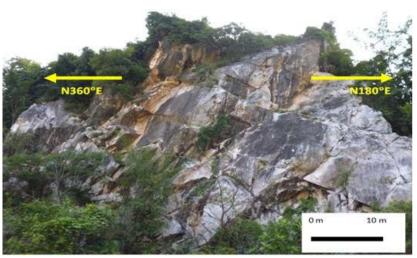
Fig-5: Slope of GL3, Gunung Lang, Ipoh, Perak

Fig-11: Kinematic analysis for slope of GL3 using friction angle of 43°. From the kinematic analysis, a planar and a wedge failure were identified. The dip direction/dip angle for respective wedge and planar failure were 345°/65° and 280°/79°

Parameter	Value	Rating
Uniaxial compressive strength, UCS	53.6 -83.4 MPa	7
Rock Quality designation, RQD	99 %	20
Spacing of discontinuities	0.62 m	15
Condition of discontinuities	Discontinuities length 1-3 m, separation 0.1 - 1.0 mm, rough, no infilling, unweathered	25
Ground water condition	Completely dry	15
RMR _b		82

Based on the [5] recommendation, the results of assessment on slope of GL1, GL2 and GL3 are exhibited in Table 5. The respective SMR rating for GL1, GL2 and GL3 were 77, 77 and 31.5 - 65. The classes of respective slopes were from class II to IV. The assessment revealed that the slope of GL1 and GL2 are stable with the probability of failure of 0.2. The stabilities of GL3 slope are from partially stable to unstable with the probability of failure of 0.4 to 0.6.

Slope	Mode of failure	RMR _b	F1	F2	F3	F4	SMR	Class	Stability	Probability of failure
GL1	No failure	77	-	-	-	-	77	II, Good	Stable	0.2
GL2	No failure	77	-	-	-	I	77	II, Good	Stable	0.2
GL3	Wedge 345°/65°	82	0.15	1	-60	-8	65	III, Fair	Partially stable	0.4
	Planar 280°/79°	82	0.85	1	-50	-8	31.5	IV, Bad	Unstable	0.6

The assessment revealed that the slope of GL1 and GL2 are stable with the probability of failure of 0.2. The stabilities of GL3 slope are from partially stable to unstable with the probability of failure of 0.4 to 0.6. According to [5] recommendation, the suggested support methods for GL3 slope are installation of surface drainage, shotcrete, dental concrete and toe walls.
