State of Hydraulic Works Following Successive Floods in the Irrigated Area of Aneker-Tahoua-Niger

This study was carried out on the irrigated area of Aneker, Tahoua region (Niger), the objective of which is to analyze the physical state of hydraulic structures following flooding on this development. Its objective is to make an exhaustive diagnosis of the irrigation and drainage networks. The methodology consisted of the development of two (2) survey sheets, one of which was administered to irrigators and the other with ONAHA technicians. The other was used to explore a certain number of hydraulic works such as irrigation canals, protection and drainage networks, in order on the one hand to assess the physical state of these works and on the other hand to complete data collected with operators and technicians. Thus, the collected data was processed and analyzed. The results of this study show a notable deterioration of hydraulic infrastructure which affected the operating performance of the study area and development. It emerges from this study that the perimeter is faced with the problems of cracking observed on the canals, the lack of seals, the degradation of the jumpers, the pr

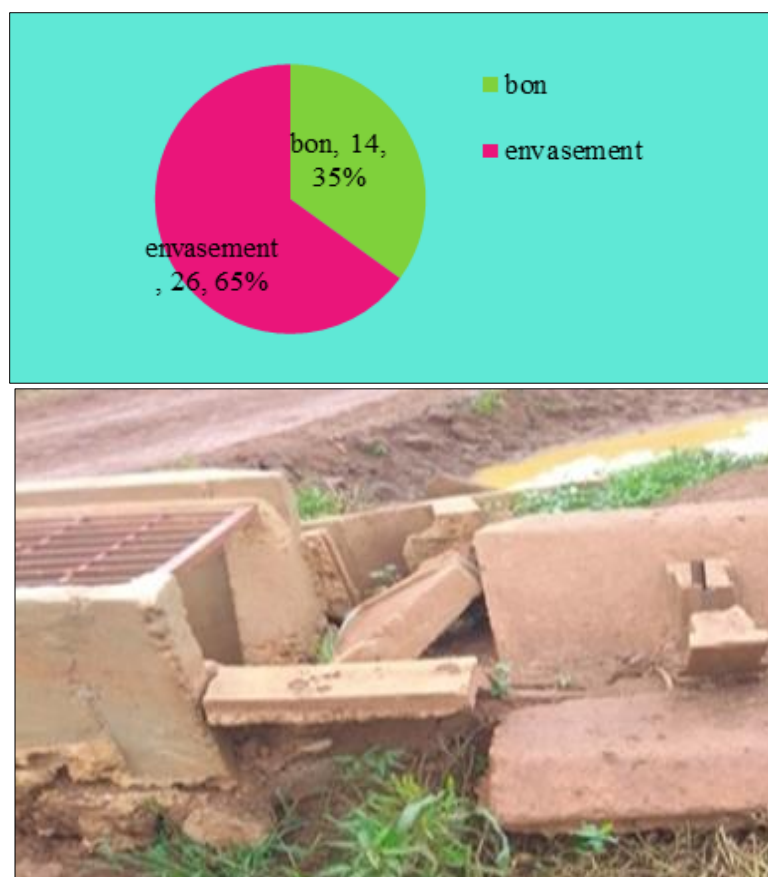
The main intake structure is located upstream of the primary canal. There are a few intake structures of which 65% are in a state of siltation or even cracked and 35% are in good condition as illustrated in Figure 1.

Figure 1 : state of intake structures on the Aneker irrigated perimeter
(Source : YERIMA., 2022)

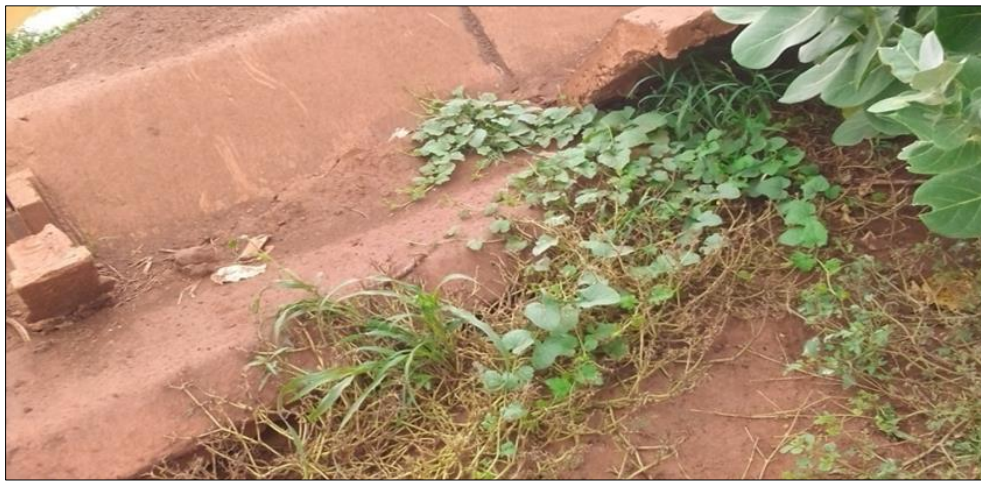
The water distribution works are in poor condition, especially the primary and secondary canals which are currently in various degraded states. The main canals present anomalies, most of which are either broken, detached, loose, cracked or good as illustrated in Figure 2.

Figure 2 : condition of a portion of the main canal at the Aneker irrigated perimeter (Source : YERIMA., 2022)

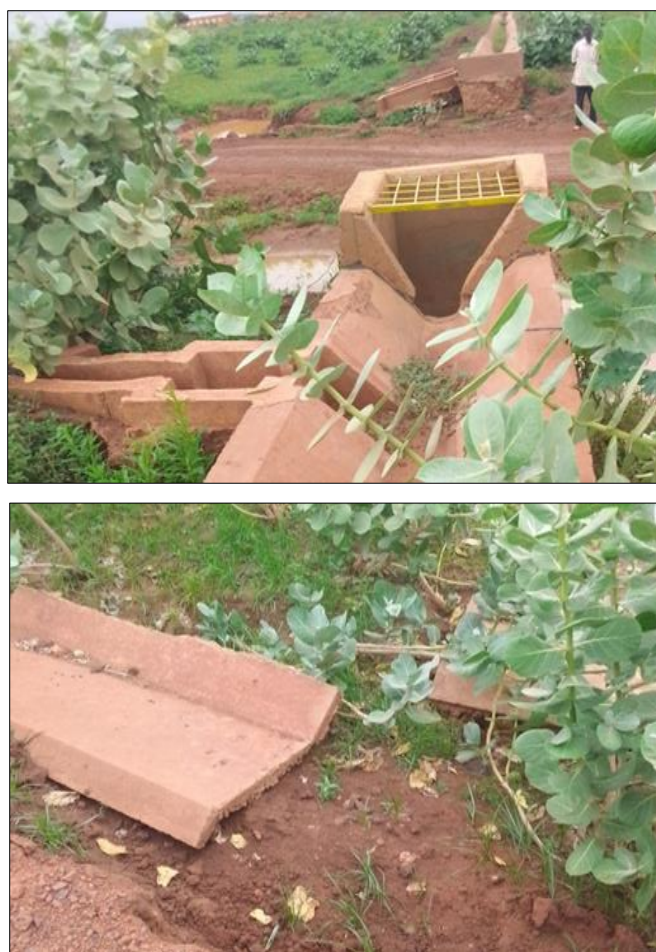
At the level of the Aneker irrigated area, the observation is that most of the secondary canals are in a seriously degraded state.

Figure 3 : Condition of secondary canals in the Aneker irrigated perimeter
(Source : YERIMA., 2022)
