Management of Fractured Maxillary Incisors with Translucent Zirconia Crowns: A Case Report

Case Report

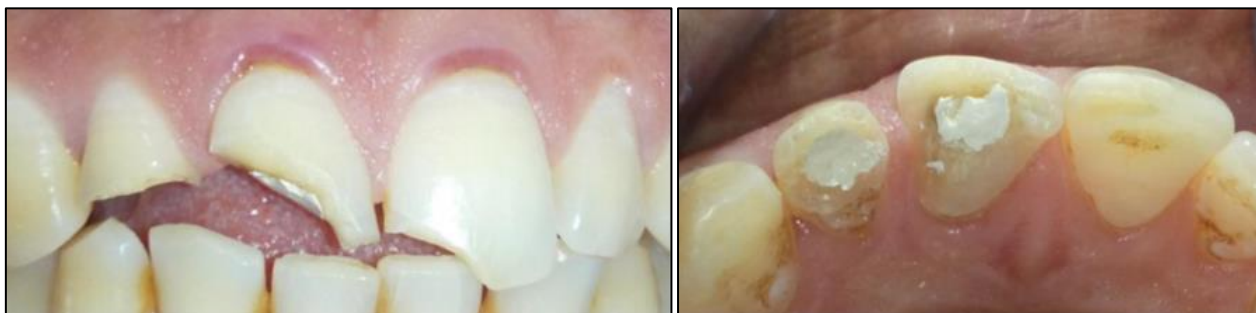
The intraoral examination revealed that the left central tooth was asymptomatic, with a coronal fracture limited at the incisal edge, the vitality test was positive, and the percussion and palpation tests were negative.

The right lateral and central teeth were severely damaged with a coronal destruction associated with pulp exposure. X-ray examination did not reveal any root damage or apical translucency.

Fig. 1: Labial and incisal view of the fractured teeth after root canal treatment

Treatment options were presented and discussed with the patient. Considering the clinical situation, it was planned to carry out an endodontic treatment followed by fiber posts and cores build up on #12 and #11 teeth before the placement of definitive crowns while #21 needed a resin composite stratification.

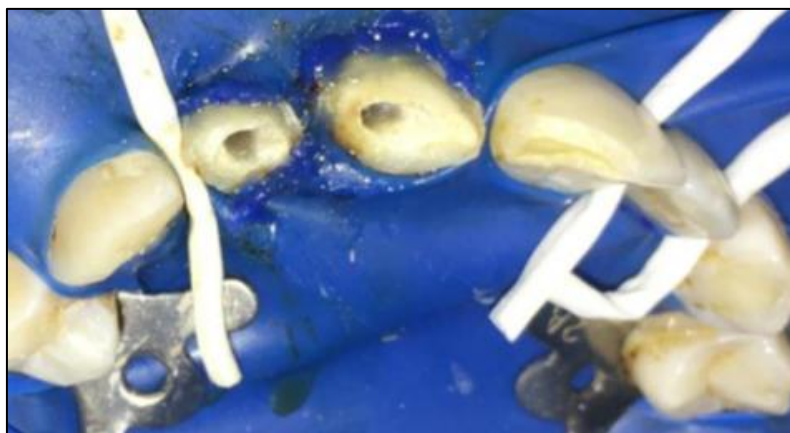
Fig. 2: The rubber dam is positioned to perfectly isolate the tooth from the biological fluids (saliva and blood)

In the following appointment, the intrasulcular preparation limit was performed as a shoulder with rounded inner angle, then fiber post spaces preparations were carried out using peeso reamers (#1, #2, #3) leaving the 5mm of apical gutta percha seal intact (Figure 2).

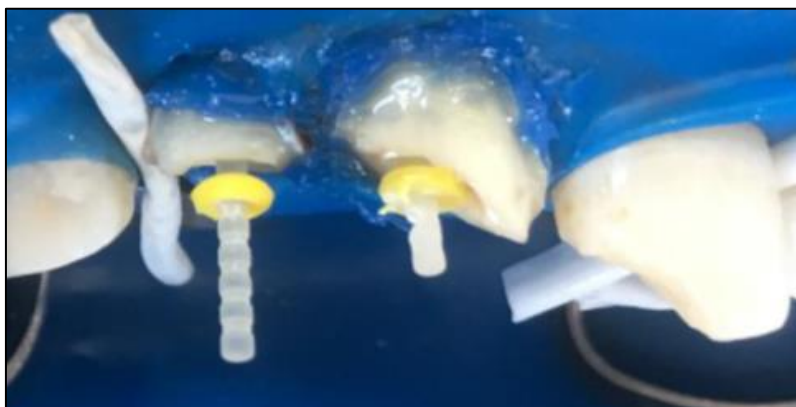
Fig. 3: Fiber posts were tried and adjusted at the adequate prepared root length

The selected fiber posts (Fiber Post Refill Dentoclic, ITENA Clinical Dental Post, France) were demarcated (figure 3) reduced to an adequate length by

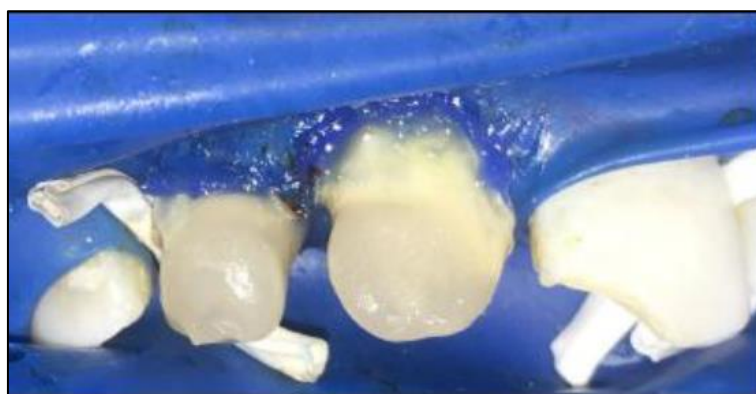
Fig. 5: cores build up on #12 and #11 teeth

Dual cure cement (Nova resin, IMICRYL®) was used for post cementation. The posts were seated and excess material removed before light curing. Cores

build up were done with composite (Composite Empress Direct - Ivoclar Vivadent).

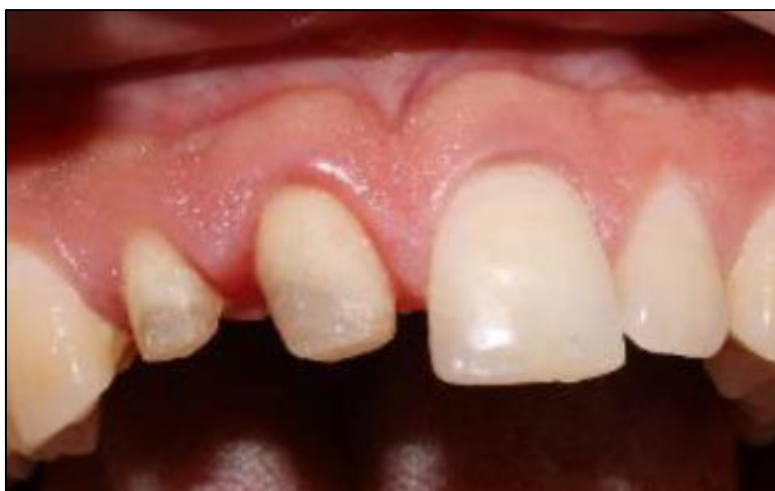
Fig. 6: tooth preparations on #12 and #11 teeth and composite resin stratification on #21

The teeth were subjected to dental preparation rectification after cores build up with rounded shoulder

margin. The cutting depth at the preparation limit was ranging from 1 to 1.2 mm (Figure 6).

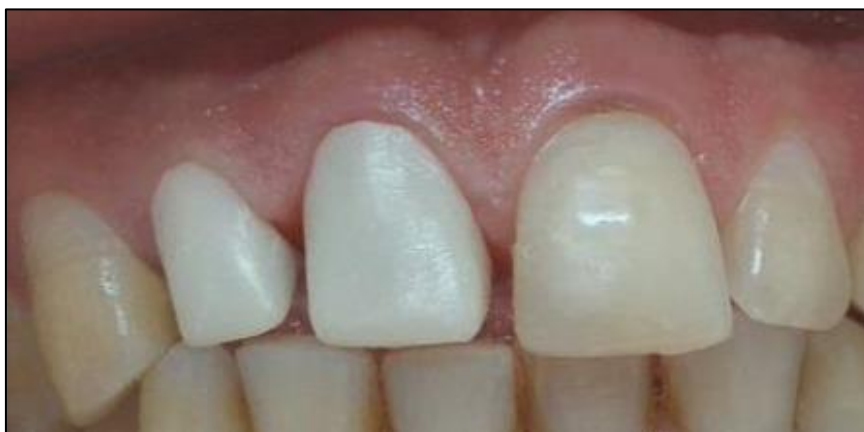
Fig. 7: trying in of frameworks

The all-ceramic crowns were tried on the cores and checked for marginal fit, occlusion and esthetics. Gingival retraction was performed before cementation to enable the removal of the excess luting agent. Final cementation was carried out using self-adhesive dual cure composite resin (Nova Resin, IMICRYL®) (Figures 7 and 8).

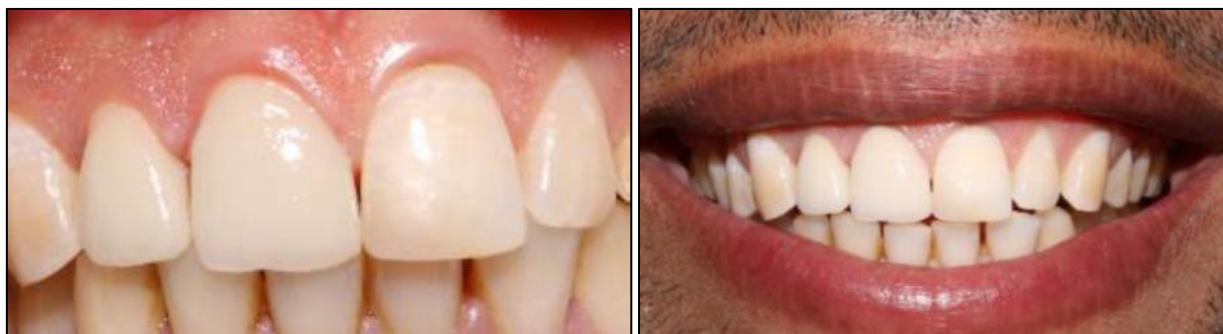
Fig. 8: final result: aesthetic and functional integration of all ceramic crowns, patient was satisfied by the result

The patient was satisfied with the shape and shade of the ceramic restorations.
