Zirconia Based Crowns for Esthetic Dental Rehabilitation: A Challenge to Overcome

Case Report

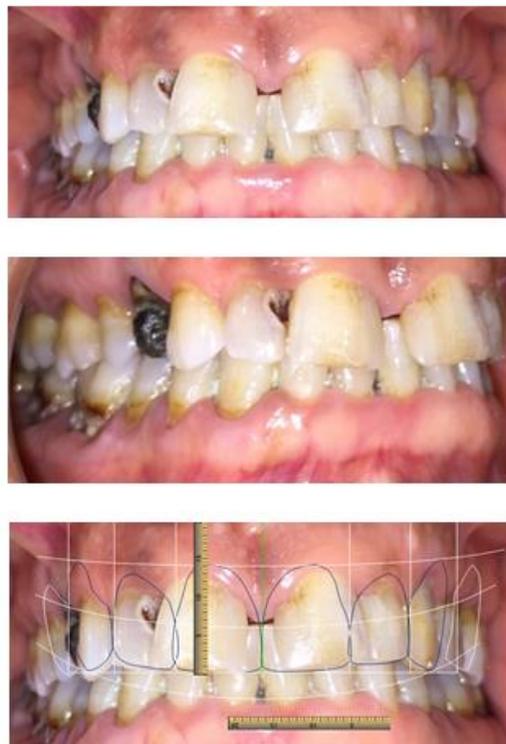
During the clinical examination, the facial aspects, the smile harmony, the gingival contour, oral hygiene and the dental characteristics were evaluated. Intra oral examination revealed the presence of midline diastema between maxillary central incisors (~2 mm) and cervical decay with significant substance loss. In the other hand, the central incisors, the right lateral incisors and canines have been filled with a composite resin dating for three years. However, the

right first premolar [14] had been filled with amalgam for five years. After this preliminary oral analysis, the incisal edge, occlusal plane and parafunctional habits were checked. A deep bite had been founded (Figure 1).

Fig-1: Intra oral views of initial situation (a,b)and Aesthetic planning(c)

According to the treatment planning and digital smile design (a virtual planning that utilizes information gathered through diagnostic procedures to create an esthetic treatment scheme) crown lengthening should be necessary to find an adequate dental proportion.

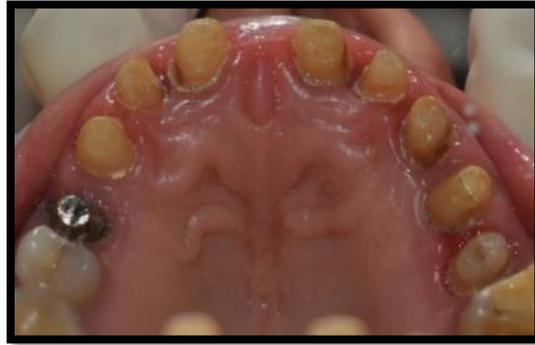
Fig-2: Prepared and restored abutments

Then, the abutment tooth of the second left premolar was refined after placement of glass fiber post and composite core built up. Moreover, the first right premolar was reconstituted with a metallic post and core (Figure 2).

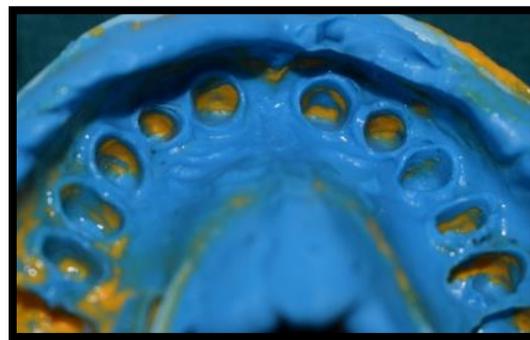
Fig-3: Arch impression after multidisciplinary treatment

A complete arch impression was made with a silicone impression material (HydroC, Detax, Germany) (a combination of heavy - and light silicon) (Figure 3). Then, it was transferred to the laboratory to be casted. The shade was determined with a shade guide (Vitapan 3D Master).

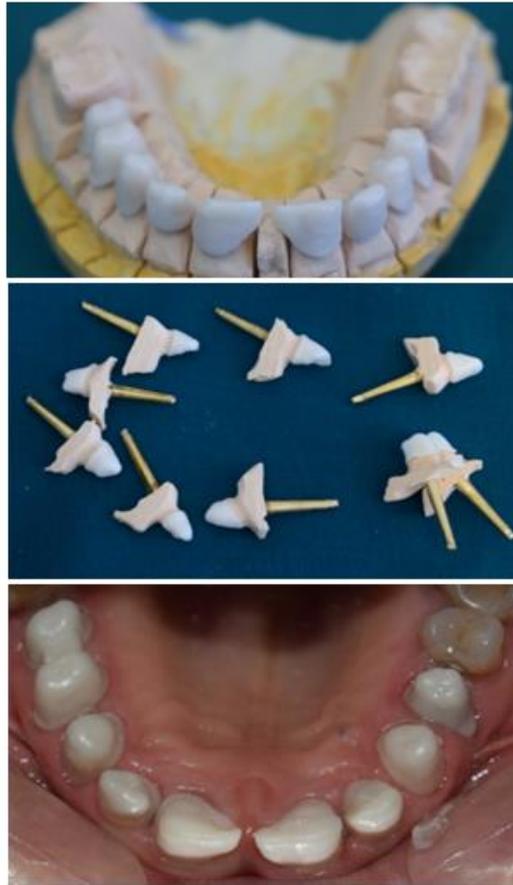
In the laboratory, Zirconia frameworks were manufactured using indirect CAD/CAM technology. Then, they were tried and the space left to the feldspathic ceramic was verified (Figure 4).

Fig-4(a,b,c): Zirconia frameworks

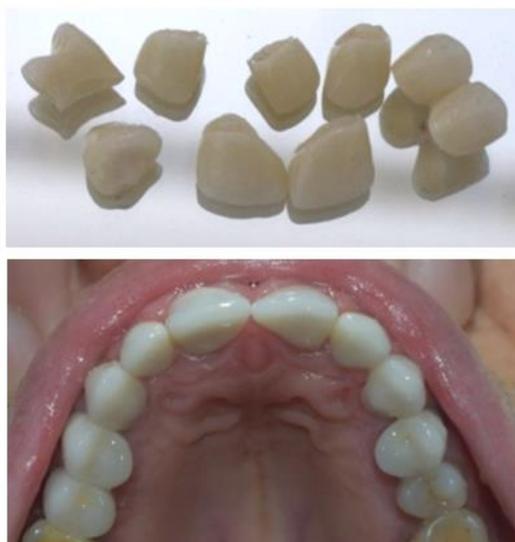
Finally, esthetic and occlusion relationship were checked and the crowns were cemented after ceramic glazing (Figures 5,6).

Fig-5: Final restorations

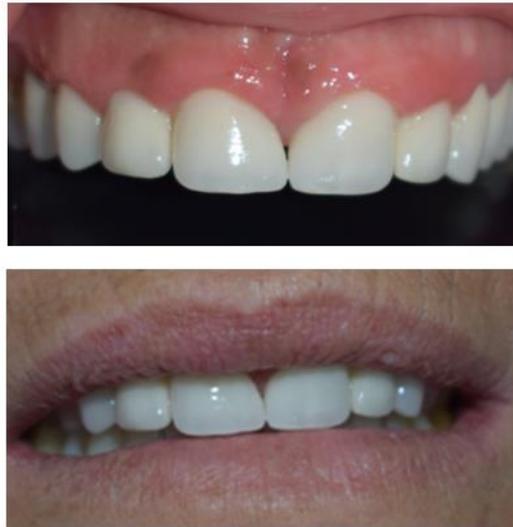
Fig-6(a-b-c): Final result
