Surgical Removal of an Extravascular Knotted J-Tip Guidewire During Subclavian Central Venous Catheterization- A Case Report

Seongmin Park, M.D¹, Seung Bae Cho, M.D¹, Jeonghan Lee, M.D., Ph.D^{1*}¹Department of Anesthesiology and Pain Medicine, Inje University Busan Paik Hospital, Busan, KoreaDOI: [10.36347/sjmcr.2023.v11i08.009](https://doi.org/10.36347/sjmcr.2023.v11i08.009)

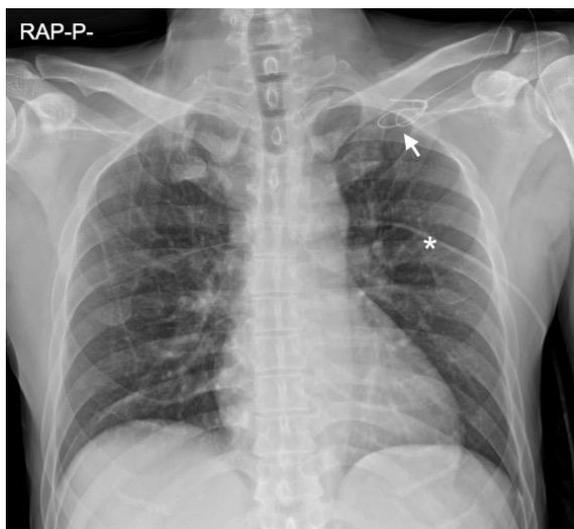
A 72-year-old male patient (65 kg, 1.70 m) was scheduled for cervical anterior interbody fusion surgery. The patient was recently diagnosed with a herniated cervical disc at the C6/7 and had no other significant medical history. One day before the surgery, the left subclavian venous catheterization was attempted via an infraclavicular approach using Seldinger Technique. The 18-gauge introducer needle was inserted to pass below the clavicle and above the first rib during the first attempt. The needle further advanced parallel to the floor, through the subclavian muscle, and entered the subclavian vein. Venous return was confirmed by desaturated blood color, and the J-tip guidewire was inserted through the introducer needle easily without any resistance. After removing the needle, a 7.5 Fr tissue dilator was threaded over the guidewire, followed by an attempt to insert the 7 Fr two-lumen catheter over the guidewire. However, the catheter did not advance more than 3 cm from the skin. At this point, attempts to withdraw the guidewire failed despite moderate force, and a portable chest X-ray revealed that the guidewire was kinked in the extravascular space posterior to the middle one-half of the clavicle (Fig 1). Additional attempts to withdraw the guidewire were made with greater force, but it could not

Figure 1: Supine anteroposterior chest X-ray was taken immediately after attempt to remove the guidewire failed. Guidewire kinking and looping (arrow) is confirmed below the left midclavicular space. Double lumen central venous catheter (asterisk) above the sterile drape sheet is shown in the X-ray

Further attempts to remove the guidewire were immediately stopped, and an aseptic dressing was applied over the whole area to cover the remaining guidewire. A cardiothoracic surgeon was consulted immediately, and a decision was made to perform surgical exploration after the induction of general anesthesia during the patient's scheduled surgery.

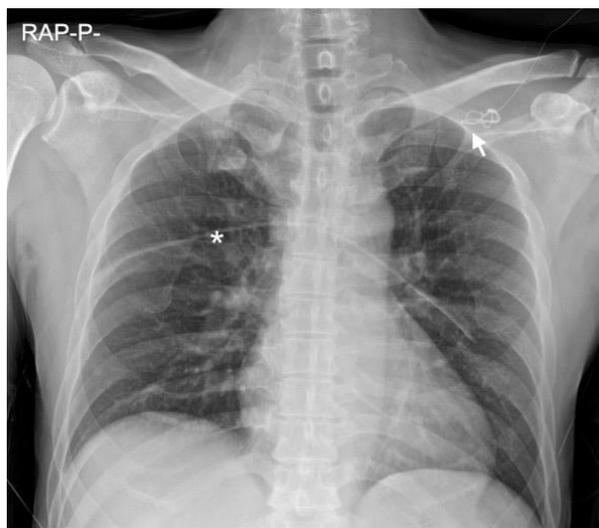
be removed. A subsequent portable chest X-ray showed a small, complicated, and firm knot (Fig 2).

Figure 2: Supine anteroposterior chest X-ray taken after additional attempts to remove the guidewire with more force failed. Smaller, firmly made knots (arrow) are formed. Central venous catheter (asterisk) above the sterile drape sheet is shown in the X-ray

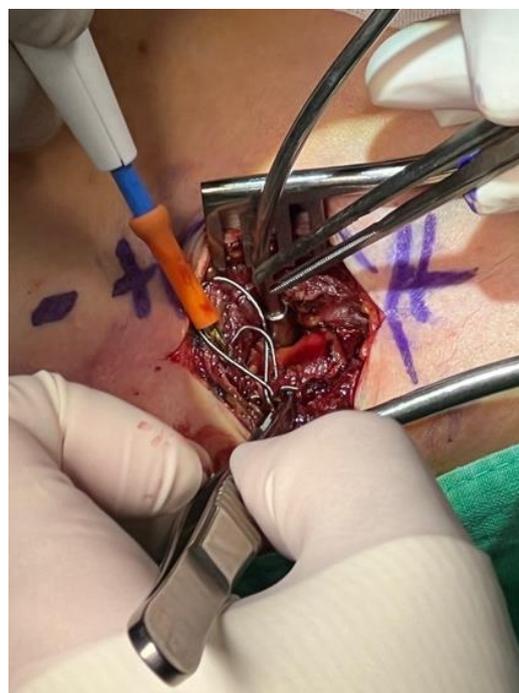
dissection of the subclavian area was performed by a cardiothoracic surgeon. The guidewire had formed a knot between the pectoralis major muscle and subcutaneous fat (Fig 3) without damaging nearby blood vessels and nerves. The guidewire was cut, and the remaining portion of the guidewire was successfully removed (Fig 4).

Figure 3: Kinked and knotted guidewire was surgically removed from subclavian space between pectoralis major muscle and subcutaneous fat

In the operating room, a 4 cm incision was made medial to the guidewire insertion site, and careful

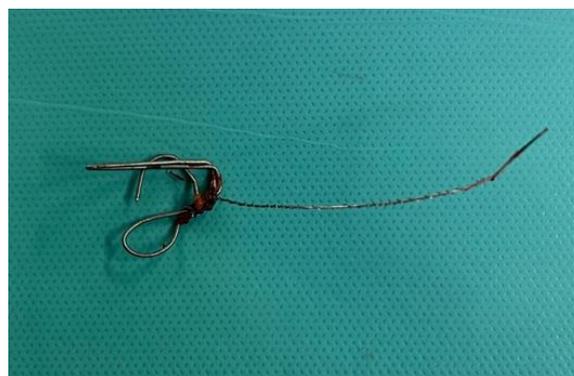
Figure 4: The J-tip guidewire was cut and surgically removed from the patient. The segment of the guidewire in the patient was 15 cm in length with firmly made knots. The J-tip of the guidewire was intact, however the outer coiling wire that is attached to the inner filament wire came apart

To prevent guidewire-associated complications and handle the guidewire skillfully during CVC, it is important to comprehensively understand the guidewire structure and factors contributing to its kinking, knotting, and breakage. A J-tip guidewire consists of two parts, an inner single filament wire core surrounded by an outer covering wire that coils its entire length, and both parts are welded together at both ends [5]. The weld seam can only withstand a pull strength of approximately 17 N (1.73 kg force), whereas the entire guidewire can withstand a stress of approximately 290

N (29.57 kg force) [5]. Therefore, excessive force applied to the guidewire should be avoided to prevent the detachment of the inner wire from its outer coil.

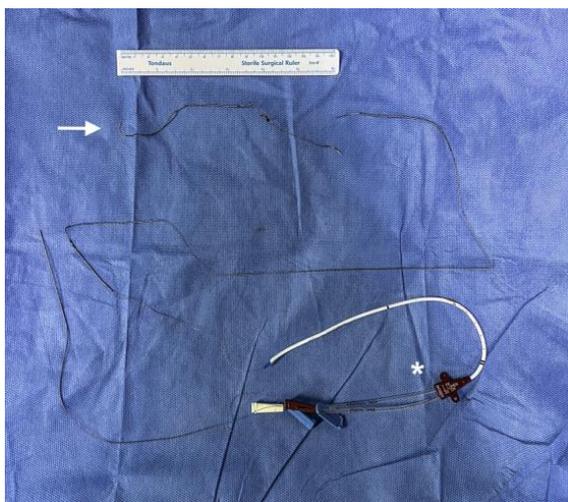
A portable X-ray in the operation room was used to check for any remaining fragments within the patient's body. Both portions of the cut guidewire were put together to visually confirm the full removal of the guidewire (Fig 5). The incision site was sutured, hemostasis was checked, and the patient underwent his scheduled cervical anterior interbody fusion surgery. A

Figure 5: The removed knotted guidewire segment (arrow) was disentangled and arranged with the remaining guidewire and central venous catheter (asterisk) to visually confirm that no fragments remained in the body
