## Subtrochanteric Fracture on a Pre-Existing Femoral Plate: A Case Report of Secondary Fracture Management with Dynamic Hip Screw Plating

### Case Report

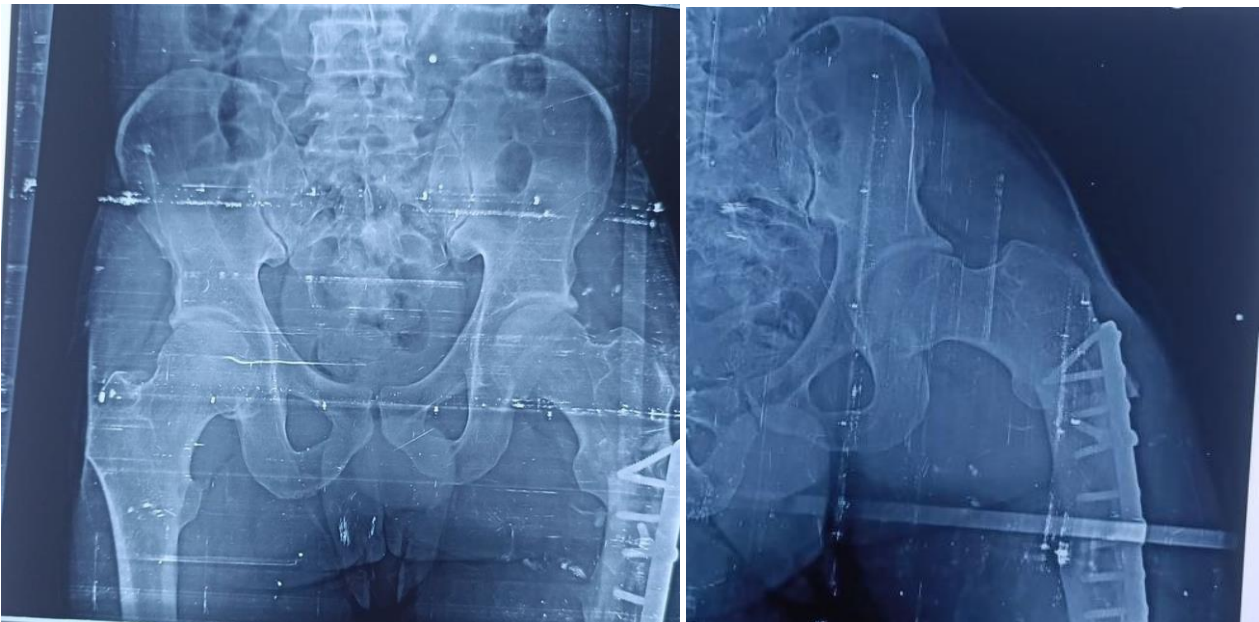
**Figure 1: Preoperative plain radiographs. (A) Anteroposterior view of the pelvis demonstrating the pre-existing lateral femoral plate in situ on the left femur. (B) Closer view showing the subtrochanteric fracture line originating at the proximal screw hole of the retained plate, consistent with a stress-riser fracture pattern**

Anteroposterior plain radiographs of the pelvis and left femur demonstrated a transverse subtrochanteric fracture of the left femur localised at the proximal extremity of the pre-existing lateral femoral plate. The fracture line originated at the level of the most proximal screw hole of the retained plate, consistent with a stress-riser fracture pattern at the implant tip. The old plate appeared well-fixed distally with no evidence of loosening or cortical lysis along its length. The contralateral hip and the lumbar spine appeared radiographically normal.

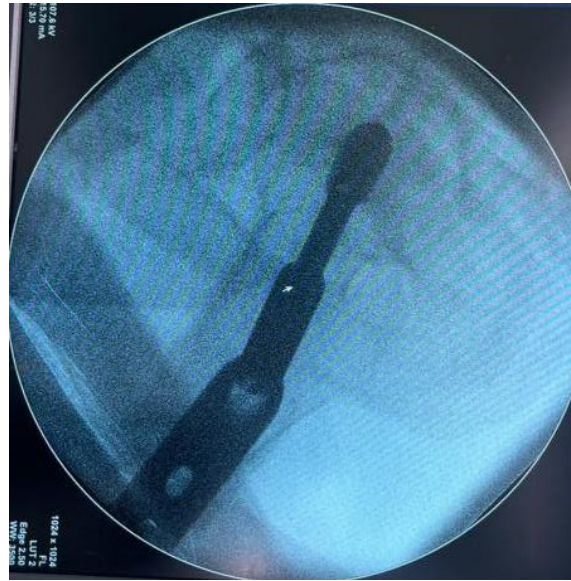
**Figure 2: Intraoperative fluoroscopic image confirming satisfactory positioning of the dynamic hip screw lag screw within the femoral head-neck axis and adequate apposition of the DHS, Following removal of the pre-existing plate**

guidance. A dynamic hip screw (DHS) plate system was applied, incorporating the proximal femoral fragment with a lag screw directed into the femoral head and neck, and a lateral plate affixed to the femoral shaft. Intraoperative fluoroscopic images confirmed satisfactory reduction and appropriate positioning of the DHS construct relative to the femoral head and neck.

The intraoperative fluoroscopic images confirmed satisfactory lag screw placement in the femoral head-neck axis and adequate DHS plate apposition to the lateral femoral cortex, providing stable fixation of the subtrochanteric fracture.

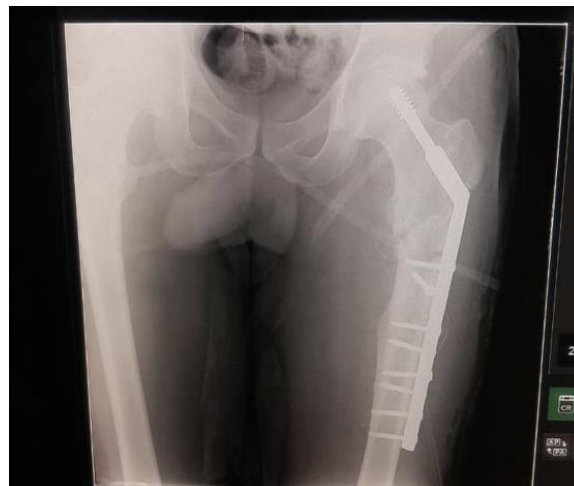
**Figure 3: Postoperative anteroposterior radiograph demonstrating the dynamic hip screw (DHS) construct with satisfactory reduction of the subtrochanteric fracture**
