Interest of Biodentine as Pulp-Capping Materiel under CAD/CAM Ceramic Inlay

Case Report

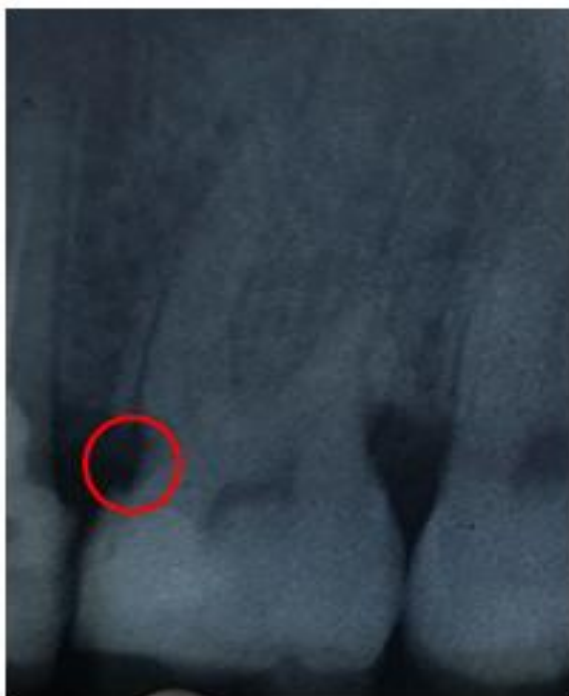
A 33 years old female patient reported to our department with the complaint of pain in the first upper left molar recently restored with composite resin. Initially, the tooth were tested positive on pulp vitality and negative on percussion. Radiographic evaluation revealed that there was a critical proximity between the composite restoration and pulp (Figure-1). The patient was informed about the need of removing the composite filling and the possibility that an endodontic treatment would be required.

Fig-1: Radiograph before the composite removal

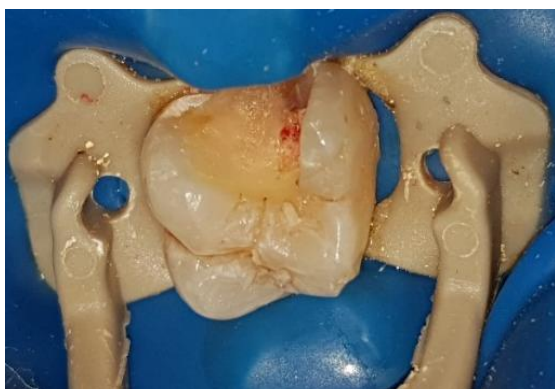
After patient consent, local anesthesia was performed and a rubber dam was placed to avoid contamination with saliva. The removal of composite restoration provoked an iatrogenic pulp exposure (Figure-2). Clinically the pulp of the tooth at the exposure site was vital without any major bleeding, so we have opted for the maintenance of tooth vitality by direct pulp capping.

Fig-2: Pulp exposure

The control of the hemorrhage was achieved by pressing moist cotton pellets on the pulp wound for 1–2 min and then we have disinfected the cavity with 3% sodium hypochlorite and gently dried the surrounding dentin it a two-way syringe.

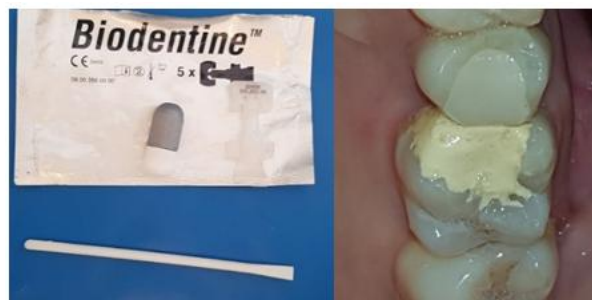
Biodentine™ (Septodont) was chosen as a pulp capping and provisional filling material. It was placed as a bulk material to restore the entire cavity (Figure-3). The material was left in place for 6 weeks.

Fig-3: Biodentine™ placed as a bulk material to restore temporarily the tooth exposure

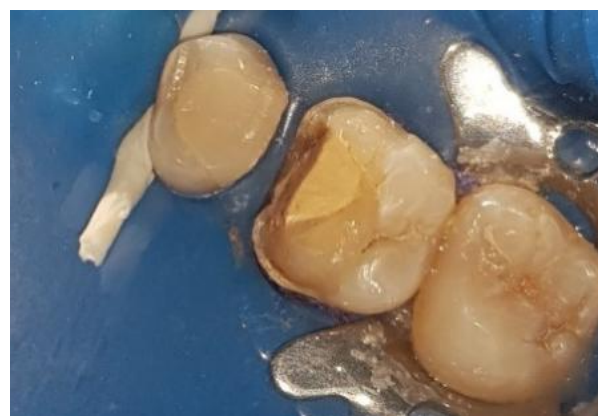
The patient reported that the tooth remained symptom free during the 6 weeks period. Nevertheless, she was tested positive to the cold spray test. The biodentine filling was reduced and kept as dentin substitute (Figure-4). Then, the tooth was prepared for receiving an hybrid ceramic inlay and a final impression was taken using the one-step putty-wash technique.

Fig-4: Biodentine™ was partially removed to serve as a dentin substitute and the tooth was prepared for receiving a hybride ceramic inlay

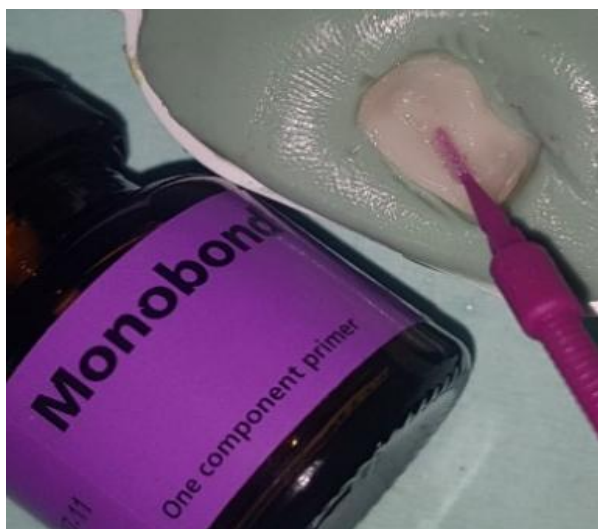
9% is applied on the underside surface of the prosthesis and then rinsed with water and air-dried. Silane is applied to the restoration and to the composite build-up for one minute and then completely air-dried (Fig-6).

Fig-6: Application of the silane on the underside surface of the restoration with a microbrush after etching

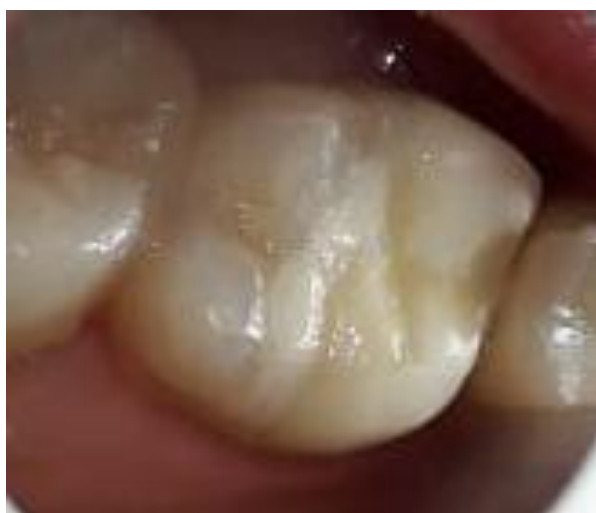
The dual cure resin cement was applied on the restoration the restoration is then placed into the cavity and firmly pushed allowing the excess material to flow out of the cavity. We can use a brush to remove the little bit of composite cement from the restoration-tooth interface. Initial polymerization is done under mild pressure with an instrument. Another polymerization cycle is carried out under glycerin to isolate completely from oxygen that might inhibit curing of the outer layer. Once the rubber dam is removed, occlusion is checked and final surface polishing is performed (Figure-7).

Fig-7: Definitive restoration after checking the occlusion

One week after Bonding, the patient was re-examined and reported no postoperative sensitivity.
