Experimental Study on Damage Characteristics of Corroded Steel pipe Based on Acoustic Emission Technology

The corrosion damage of steel pipe is mainly characterized by crack initiation and local wrinkling. One of the effective methods to evaluate the damage degree of steel pipe is to find out the law of crack initiation. The research object of this test was Q235 steel pipe specimen with diameter of 700mm, wall thickness of 5mm and height of 260mm. Acoustic emission technology was used to conduct real-time axial compression detection on corroded steel pipe specimens. The relationship between acoustic parameters (cumulative ringing number and amplitude) and the damage degree of steel pipe specimens was established, and the crack propagation law and crack initiation load of steel pipe after corrosion damage were obtained. By analyzing the different characteristics of the relationship between the displacement of loading point and acoustic parameters, the general position of steel pipe damage was detected and the exact value P of crack initiation load was determined. The experimental results provide a basis for further research on the damage mechanism of steel tube specimens. The test

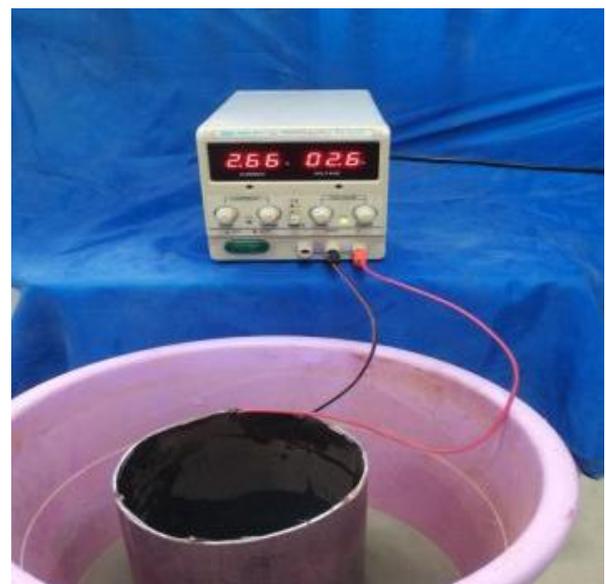
Fig 2: Steel pipe corrosion

Take Q235 steel pipe as the test object, the corrosion area is from the bottom to the height of 145mm. The two poles of the power supply were connected to the steel pipe and copper sheet respectively, and then put into the prepared NaCl solution to start the electrochemical corrosion test, as shown in Fig 2. There was no obvious change in the solution at the beginning of the corrosion test, and the solution gradually turned reddish brown the next day. At this time, the steel pipe began to be corroded. After three days, the color of the solution deepened further, and at the same time, impurities began to be generated in the corrosion area and adsorbed on the steel pipe surface. On the fifth day of corrosion, the steel pipe surface was covered with green impurities. During the corrosion process, some parts near the copper strip were seriously corroded and fell off in a large area. The corroded steel pipe is shown in Fig 3.

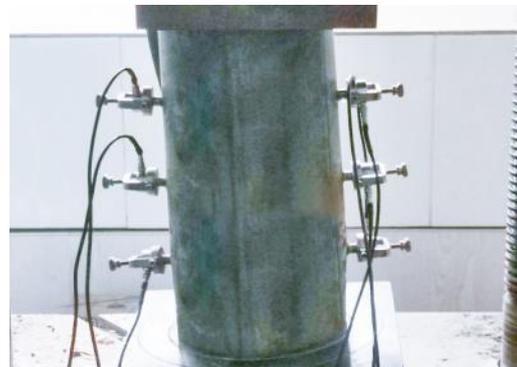
Fig 6: Steel pipe pre-loading

The schematic diagram of the test loading device is shown in Fig 5. After ensuring that the sensor is connected to the acoustic emission device correctly, the loading system is started to use the steel pipe for a certain amount of pre-loading, which is intended to reduce the frictional noise generated between the loading machine and the steel pipe, so as not to cause the acoustic emission to collect too much noise to affect the test results, as shown in Fig 6. During formal loading, the loading device is loaded by displacement control, and the rate is kept at 0.2mm/s. Finally, the data of load, ringing count and displacement of loading point with time are recorded by computer. The loaded steel pipe is shown in Fig 7.
