### **Intra-radicular Rehabilitation of Tooth Using Composite Resin with Light Transmitting Post –A Case Report**

**Abstract:** This case report highlights the management of structurally compromised fractured anterior tooth. The canal was reinforced intraradicularly with flowable composite and light transmitting glass fibre post, rendering the endodontically treated root capable of supporting the post and core and thereby ensuring continued function of badly damaged tooth.

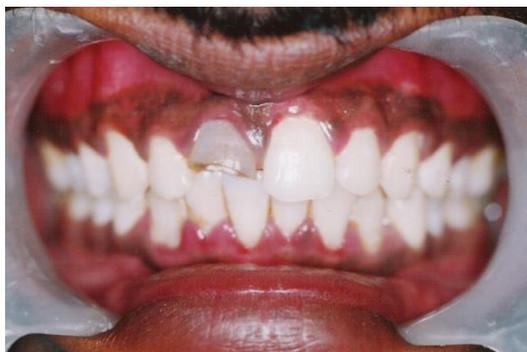
Fig 1: Pre- operative photograph

A 21 year old male patient reported to the department of Prosthodontics for the treatment of fractured and discoloured anterior teeth. Patient gave history of trauma to the front teeth 2 years back. Patient had no complaint of pain, sensitivity or any incidence of intra or extra oral swelling. Clinical examination revealed Ellis class III fracture to maxillary right central incisors (Fig 1). An intra oral periapical radiograph showed periapical radiolucency with a flared canal due to internal resorption (Fig 2). The tooth tested negative on vitality testing. Since the remaining

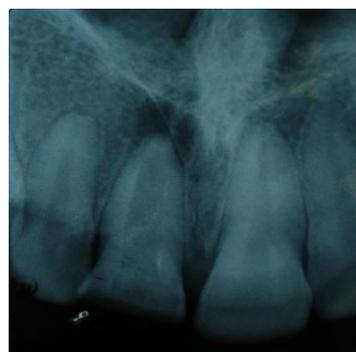
Fig 2: Pre -operative intra oral radiograph

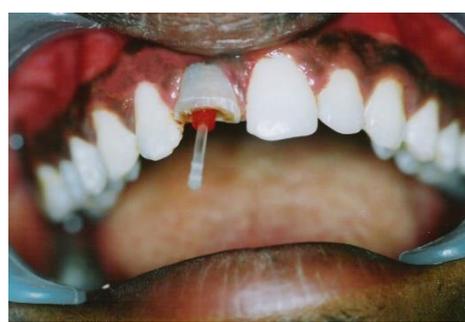
Fig 4: Luminex light transmitting plastic post

dentinal thickness was very less, intra-radicular resin reinforcement with the new Luminex light transmitting post was planned for this patient. Root canal treatment of the tooth was carried out and sectional obturation was done using thermoplasticized gutta purcha system (obtura II). A radiograph was taken to ensure the adequacy obturation (Fig3). Luminex aesthetic post system (Dentatus, USA) and a matching diameter light transmitting plastic post was selected (Fig 4) . The canal was etched with 35% phosphoric acid (EtchRite, Pulpdent, USA) for 15 sec, was rinsed with an endodontic irrigation syringe, and was dried. A thin coat of dentin bonding agent (Excite, Ivoclar Vivadent) was applied using a microapplication brush and was light cured for 20 sec. A flowable composite resin was placed into the canal. The plastic light transmitting post was centred, and the resin was cured for 40 sec. (Fig 5 & 6 ).The post was taken out, an identical diameter glass fibre post was first coated with a silane coupling agent (Monobond-S, Ivoclar Vivadent). The post was then cemented into the canal with dual cure resin

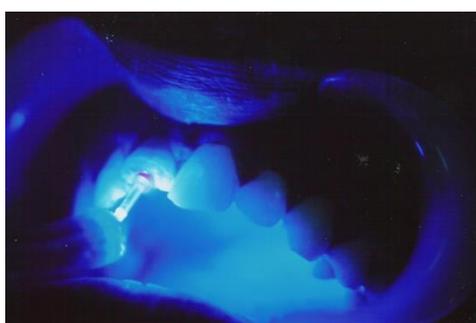
Fig 5: Light transmitting plastic post to of cure intra radicular composite resin

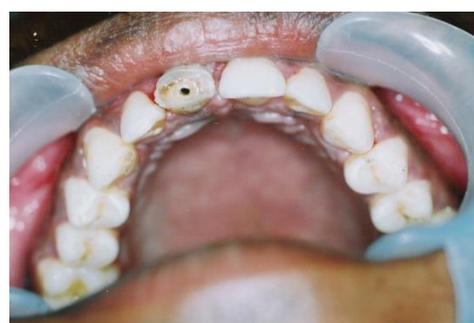
Fig 6: Reduced lumen of the canal with the help composite resin

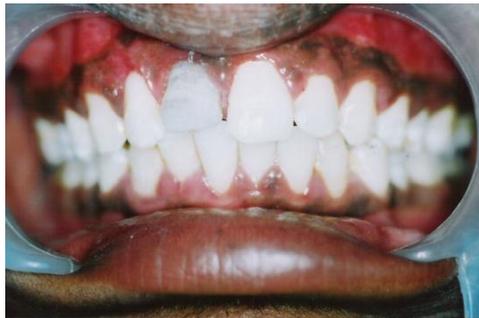
**Fig 7: Core build up with composite**

cement (Wetbond Embrace, Pulpdent, USA), which was cured for another 40 sec. Core build up was done using hybrid composite resin (Charisma, Heraeus Kulzer, Inc) in an incremental pattern, and was light-cured every time for 20sec (Fig 7). Next, the central incisor was prepared to receive all ceramic crown (Cergo, Degudent, USA). Gingival retraction was done using a knitted cord (Ultradent Products Inc., Salt Lake City, Utah) soaked in Aluminium chloride (ViscoStat Clear, Ultradent Products Inc). Definitive impressions of the prepared maxillary anterior teeth were obtained using vinyl polysiloxane impression material (Aquasil Putty and XLV, Dentsply, USA). Working casts were prepared using Type IV die stone (Ultrarock, Klabhai Dental, India). The all ceramic crown was subjected to a bisque trial to verify the colour and the contour. The final restoration was surface treated with hydrofluoric acid (Pululpdent, USA) and silane coupling agent, and cemented using dual cure resin cement (Wetbond Embrace, Pulpdent) ( Fig 8).

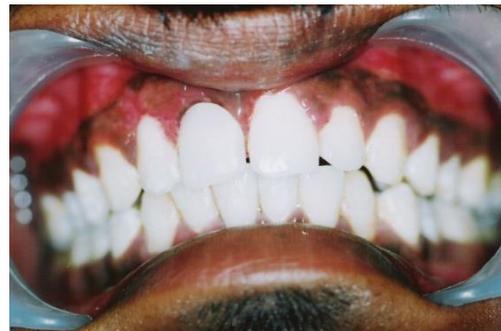
**Fig 8: Post -operative photograph**
