Tank Rehabilitation Index for a Tank Cluster

Kalaiarasi M. S^{1*}, Carolin Arul¹

Original Research Article

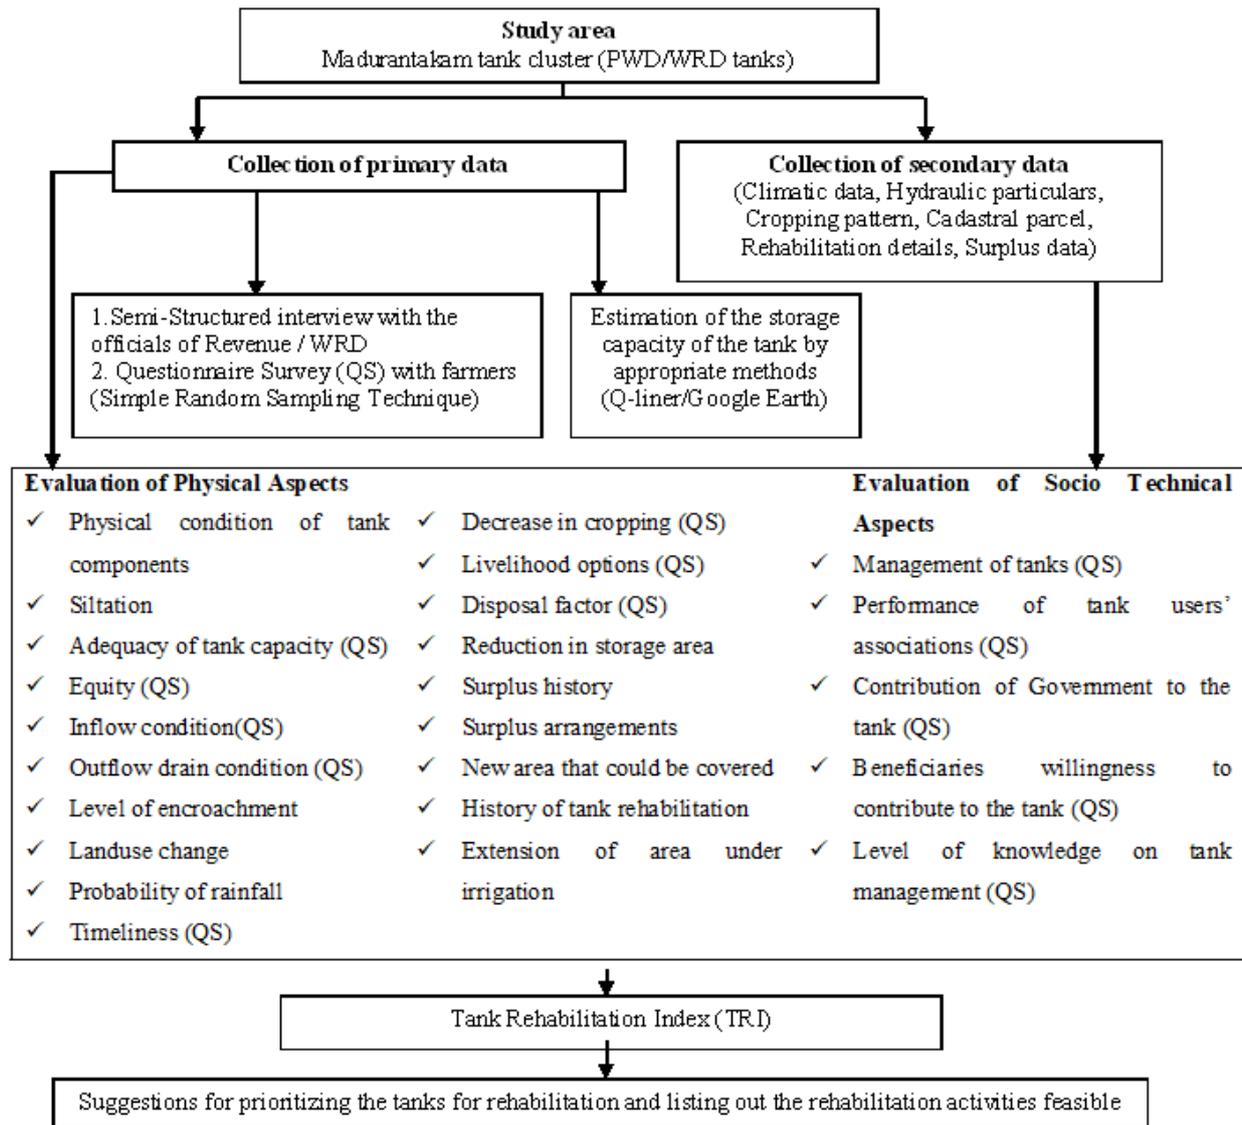
Figure 1: Methodology for Prioritization of Tanks in a Cluster

This study aimed to assess the performance of the tanks in a cluster and to derive the tank rehabilitation index based on the hydrological and physical status of tanks adopting a socio technical approach. To assess the performance of the tanks, a methodology was developed as shown in Figure 1. The sample size for the questionnaire survey is sixty.

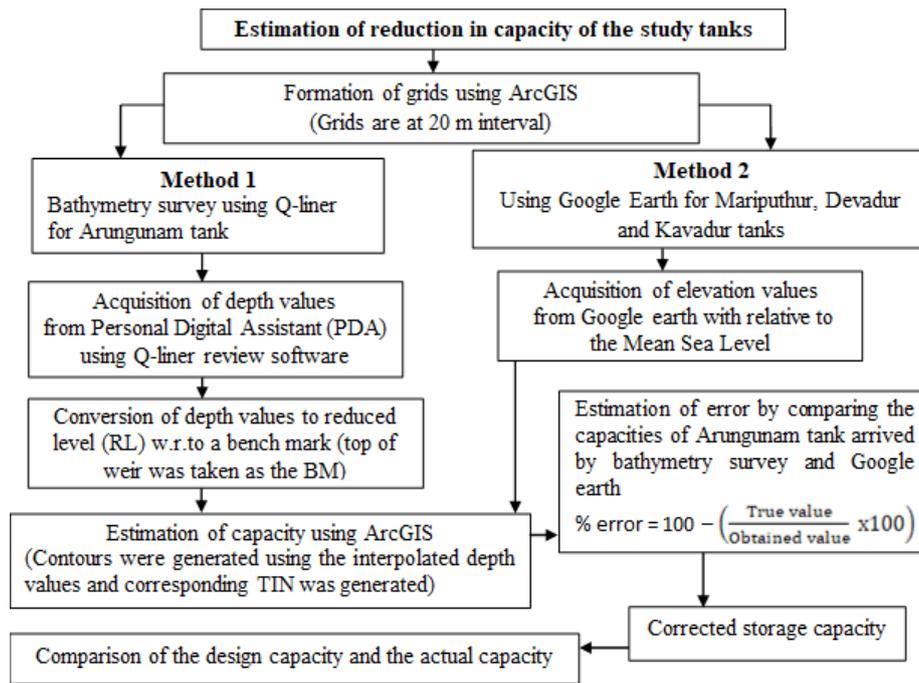
Figure 2: Capacity Estimation of the Tanks

indicator for measuring its performance and was estimated by two methods as shown in Figure 2.

The points surveyed were mapped using ArcGIS and the corresponding depth values were interpolated using Kriging method for the entire waterspread. Contours were generated from the interpolated values at an interval of 0.05 m followed by Triangulated Irregular Networks (TIN) from which the capacity of the tank was estimated using the surface volume tool.

The steps followed in capacity estimation using Google Earth were similar to that of the steps followed in capacity estimation by the Bathymetry survey, except that the elevation points were obtained from the Google Earth. The difference in capacities of the Arungunam tank was obtained from both the methods, which gave a percentage of error in the capacity estimation using Google Earth as 30%. The approximate capacities of Devadur, Kavadur and

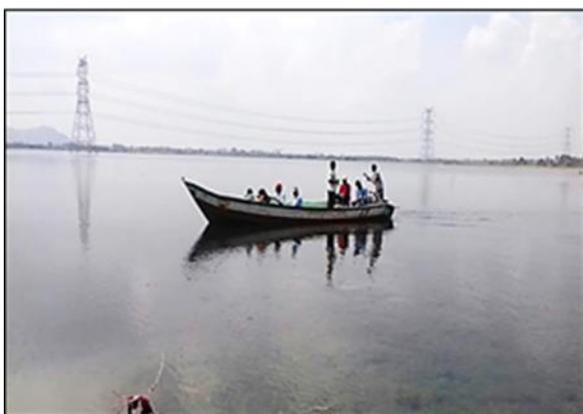
Figure 3: Bathymetry survey using Q-liner

The waterspread area of the tank delineated from Google Earth was used in the formation of grids at 20m x 20m interval using ArcGIS. Bathymetry survey was carried out in the Arungunam tank using Q-liner (Figure 3) and demarcation of the waterspread boundary was carried out using a hand-held GPS (Figure 4). The readings were taken at every 90 seconds interval along a line. Then the next line was taken up which was set out with an offset of 20m from the first line. Q-liner could be used to measure depths ranging between 0.35m to 10m. The points where the depth was less than 0.35m were measured by using a scale arrangement. Depths were measured at 148 points in the waterspread area during the survey (99 points taken using the Q-liner and 49 points using a scale arrangement). The data stored in the Personal Digital Assistant (PDA) were retrieved using the Q-liner review software. The depth values obtained from the PDA were converted to reduced levels (RL) with respect to the top of weir.
