## Single Visit Internal Perforation Repair Using a Novel HCSC and an Internal Isolation Technique: A Case Series

### Case Series

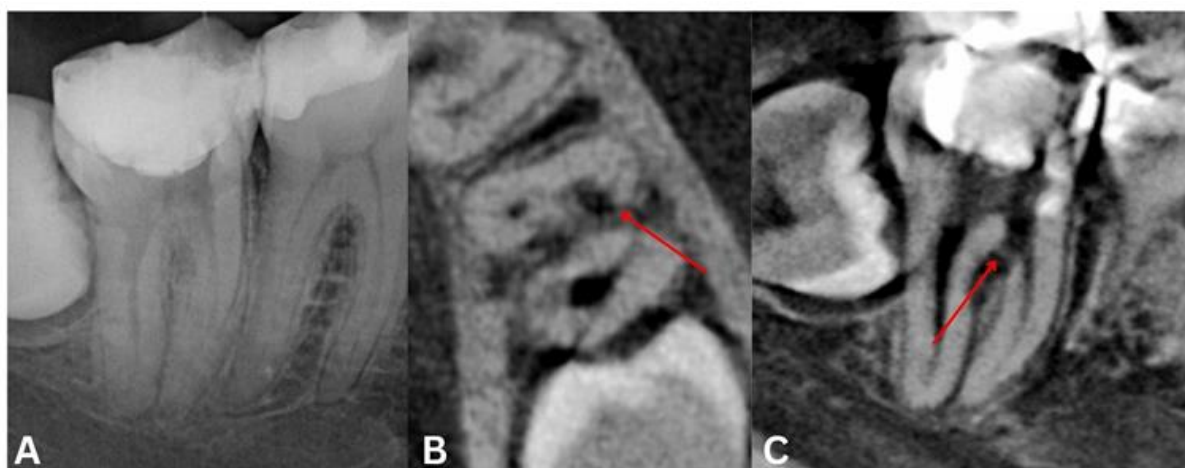
molar following an attempt to locate the mesio-buccal canal. She was asymptomatic. The preoperative periapical x-ray (Figure 1A) suggested the presence of a perforation and a small FOV 5x5 CBCT scan was taken to assess the damage. The CBCT scan confirmed the location of the mesio-buccal canal as well as the presence of a perforation involving the pulp chamber floor and part of the canal (Figures 1B and 1C).

**Figure 1: Case 1. Pre operative assessment of tooth 47. (A) The periapical x-ray showed an internal radiolucency in the mesial furcation area and a ledge on the distal canal. (B & C) The 3D imaging confirmed the presence of a perforation (red arrow) in the mesio-buccal furcation area**

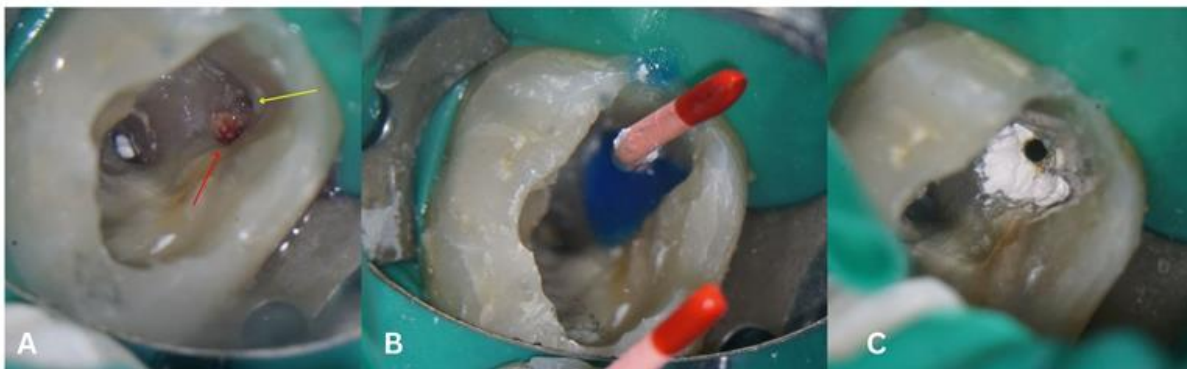
**Figure 2: Case 1. Intra operative photos. (A) Detail of the perforation (red arrow) and position of the mesio buccal canal orifice (yellow arrow) in the mesio-buccal furcation area. (B) the canal was partially shaped and a gutta-percha point was placed in order to avoid material to penetrate the canal. The perforation was then closed with HCSC and the material was then isolated with liquid dam. (C) After completing the shaping and filling of the other canals, the gutta-percha and liquid dam present in the mesio-buccal canal was removed to allow assessing the setting of the material and completing the root canal treatment**

After locating the root canal orifice (Figure 2A) and partially instrumenting the canal, a gutta-percha cone was placed in order to prevent the material blocking the lumen of the root canal (Figure 2B). Afterwards, the perforation was cleaned and carefully rinsed with 2.5% NaOCl and dried with sterile cotton wool pellets. Well-Root Pt was applied using a small amalgam plugger, before compaction and smoothing with a microbrush. The perforation site was then completely covered with liquid dam (Figure 2B).

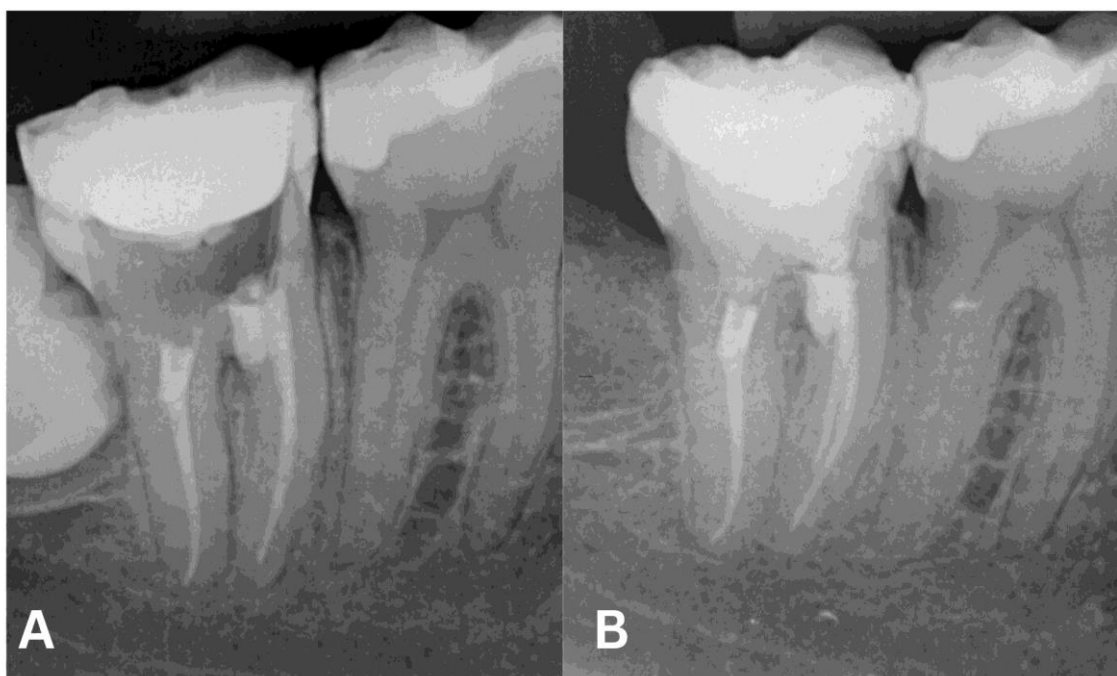
**Figure 3: Case 1. Post operative periapical x-rays. (A) completed root canal treatment and temporary filling. (B) Follow up at two years showing no signs of apical pathosis or furcal radiolucency**

The distal and mesio-lingual canals were next scouted, shaped, irrigated with 2.5% NaOCl and EDTA prior to sonic activation and sealing with single cone and a HCSC sealer (Fill-root ST, Dental-world, Molfetta, Italy). The gutta-percha that remained in the mesio-buccal canal was removed, the set of Well-Root assessed by scratching the material with an excavator and shaping, irrigation and filling was completed with the same protocol (Figures 2C and 3A). Due to patient fatigue, the tooth was restored at a second appointment using a fibre reinforced resin-based composite (Ever X Flow, GC, Tokyo, Japan) and a conventional resin-based composite (G-Aenial, GC, Tokyo, Japan). At two years follow up there is no evidence of pathology and the tooth remains asymptomatic (Figure 3B).

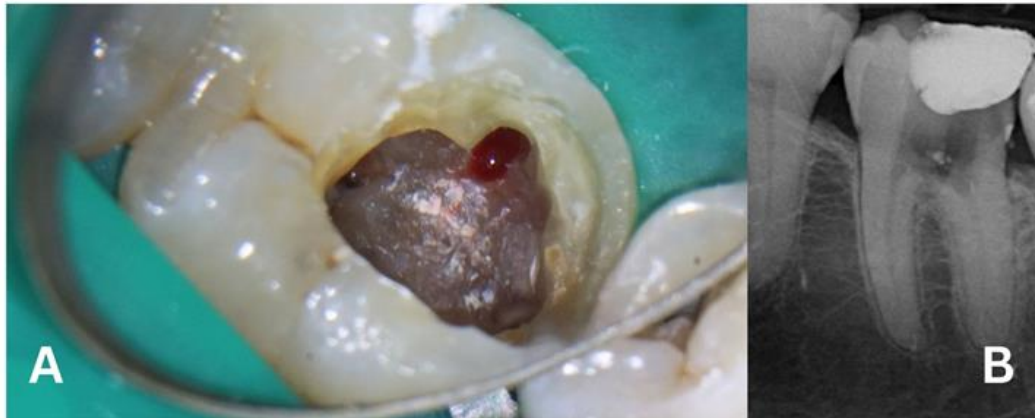
A 51 year-old female patient was referred by her dentist to a referral practice, with a report of a recent perforation that occurred while opening the pulp chamber during an emergency first stage root canal treatment on tooth 36 (Figure 4A). The patient attended the practice with a temporary filling of intermediate restorative material (IRM, Dentsply Sirona, Charlotte, North Carolina, USA) and a cotton wool pellet covering the canals (Figure 4B). The patient reported throbbing pain, that was not managed with analgesics and was disturbing sleep.

**Figure 4: Case 2. Details of the perforation. (A) Intraoperative x-ray showing the perforation of the pulp chamber. (B) Pre operative x-ray where it is noticeable the position of the perforation**

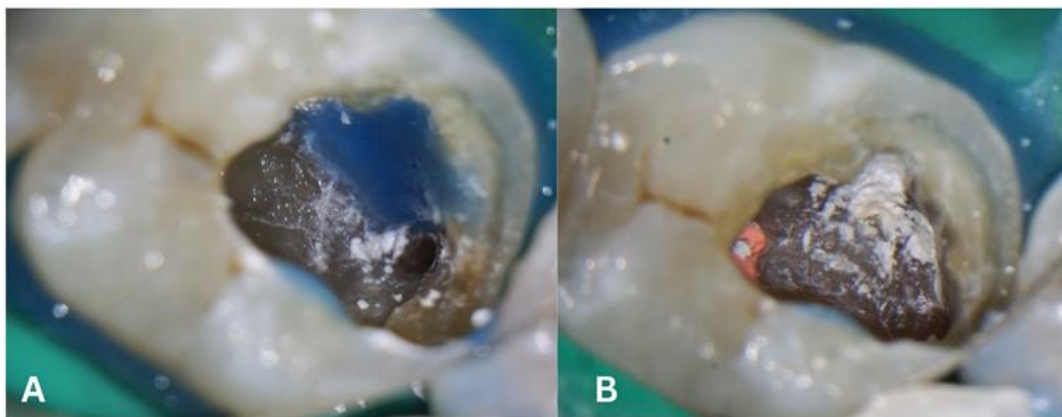
**Figure 5: Case 2. Internal isolation. (A) The perforation was sealed with HCSC and covered with liquid dam while the root canal treatment was performed. (B) After completing the filling of the root canal system, the liquid dam was removed and the setting of the HCSC assessed**

After initial instrumentation and protecting the canal orifices with gutta percha, the lesion was cleaned

with 2.5% NaOCl and sealed with Well-root PT and covered with liquid dam according to the proposed protocol (Figure 5A). Chemo-mechanical debridement with NaOCl/ EDTA was carried out prior to sonic activation and obturation with a warm vertical compaction technique. Thereafter the liquid dam was removed and the set of the HCSC assessed (Figure 5B). The tooth was restored in the same appointment using a fibre reinforced resin-based composite (Ever X Flow, GC, Tokyo, Japan) and a conventional resin-based composite restoration (G-Aenial, GC, Tokyo, Japan) (Figure 6A). The patient for financial reasons declined to have a cuspal coverage placed; however, at two and three year follow up the outcome of the treatment was successful (Figures 6B and 6C).

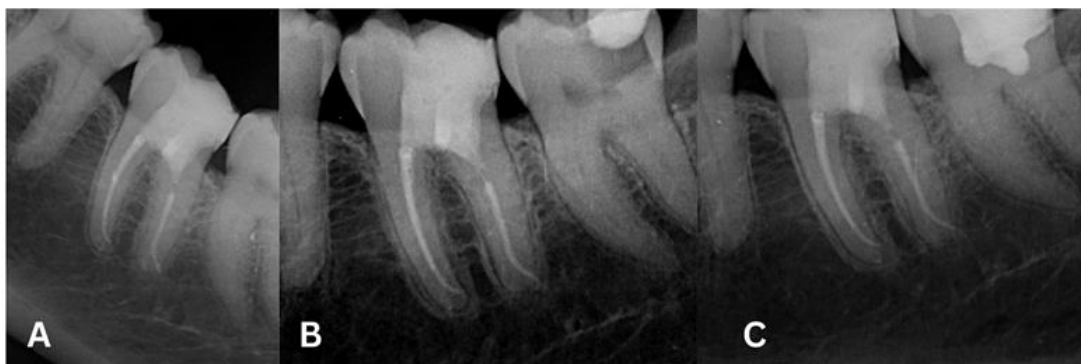
**Figure 6: Case 2. (A) Post operative x-ray after restoring the tooth with fiber-reinforced resin. (B) Two years follow up. (C) Three years follow up**

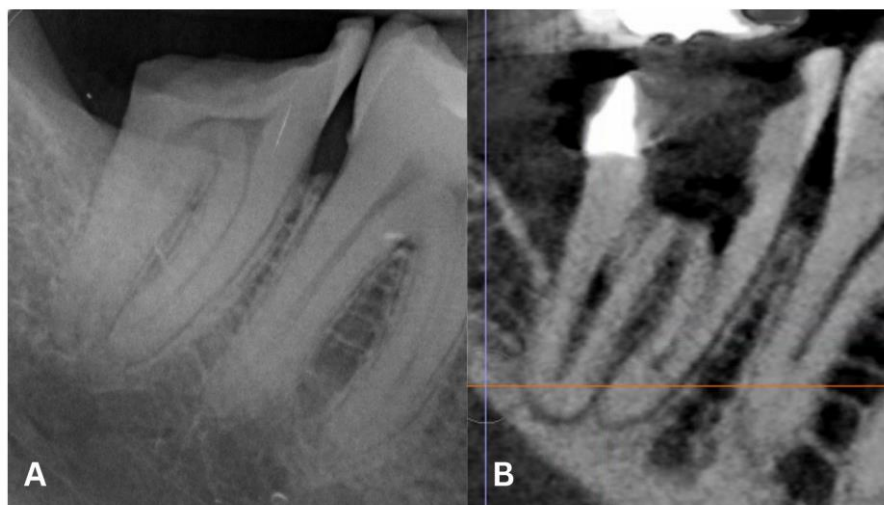
A 48 year-old male patient presented to his dentist with a broken down 47, a history of several failed adhesive restoration and evidence of pulp necrosis. During the access opening a perforation was created and his dentist subsequently referred the case for perforation management, root canal treatment and post and core placement. The referring dentist provided a pre-operative PA (Figure 7A). During the appointment a C-shape canal was suspected, therefore a FOV CBCT 5x5 was taken to

better assess the case and avoid the potential of missed anatomy (Figure 7B). The CBCT scan confirmed the presence of two canals confluent in the mesial root and a single canal in the distal root.

**Figure 7: Case 3. Pre-operative radiographs. (A) X-ray taken by the referring dentist and sent with the referral and occurred prior to the perforation. (B) Pre-operative CBCT showing a perforation of the floor of the pulp chamber**

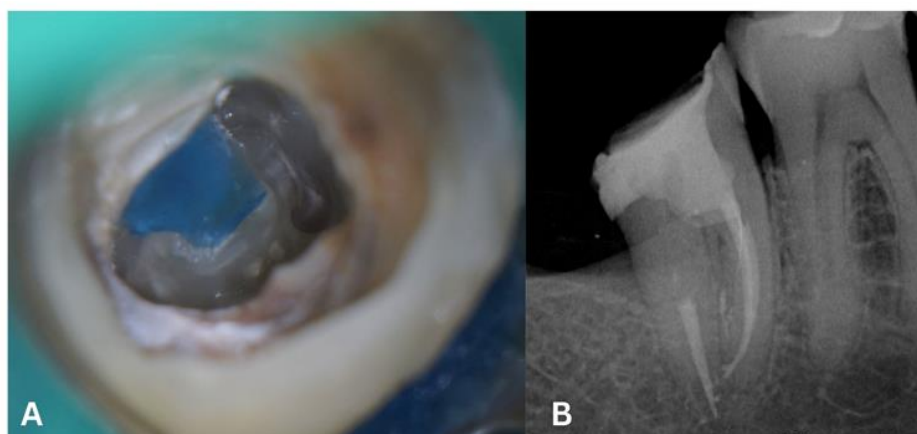
**Figure 8: Case 3. (A) Internal isolation of the HCSC using liquid dam. (B) Post op x-ray. Perforation repair, root canal treatment and post and core placement were completed in a single session**

The perforation was treated according to the protocol previously described and the root canal treatment was performed, while the HCSC was setting with liquid dam protection (Figure 8A). The final restoration was completed with a post and core as

requested by the referring dentist at the same appointment. After cementing the post, the tooth was filled with fibre reinforced resin-based composite (Ever X Flow, GC, Tokio, Japan) and a conventional resin-

based composite (G-Aenial, GC, Tokio, Japan) (Figure 8B). The tooth will be restored with crown by his dentist in the future.

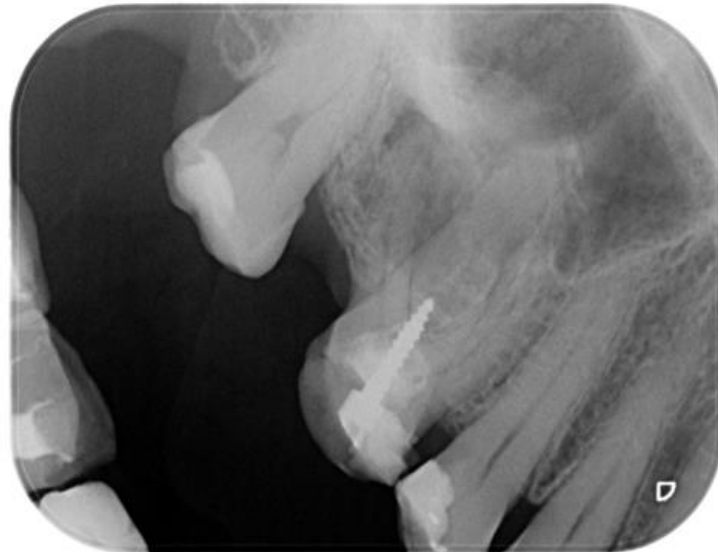
A 55 female patient was referred for a root canal treatment of a symptomatic 16 where was previously placed a dentatus post without carrying out an endodontic treatment but just a pulpectomy (Figure 9). The post was actually placed buccally in respect to the position of the palatal canal, causing a perforation. After the removal of the post, the palatal canal was scouted and grossly shaped before protecting it with a gutta-percha cone. Well- root and liquid dam were applied on the

**Figure 9: Case 4. Pre operative x-ray showing a not ideal root canal treatment and a restoration with a “dentatus” post on the palatal canal. The post was placed too buccally, perforating the root**

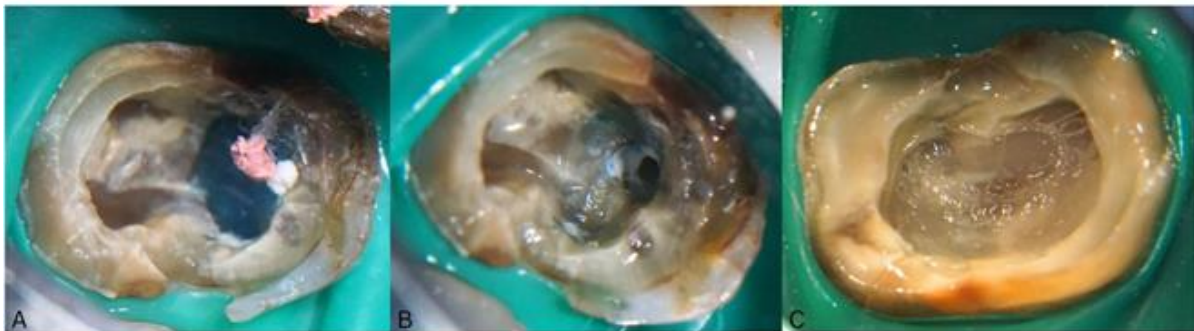
**Figure 10: Case 4. Intra operative pictures. (A) The canal was protected with a guttapercha point and Well-Root PT was applied and covered with liquid dam. (B) Once removed the protecting gutta-percha point and liquid dam, a fully set material was found while the lumen of the canal was easy to access. (C) The tooth was then restored with fiber-reinforced resin**

perforation (Figure 10 A). The distal and mesiobuccal 1 and 2 canals were next scouted, shaped, irrigated with 2.5% NaOCl and EDTA prior to sonic activation and sealing with single cone and a HCSC sealer. The liquid dam and gutta-percha point were then removed from the palatal canal: the perforation appeared sealed with a fully set material and the canal maintained full patency (Figure 10B). After cleaning and obturating the palatal canal with single cone and HCSC sealer, the tooth was restored with fiber-reinforced resin (Figure 10C and 11).

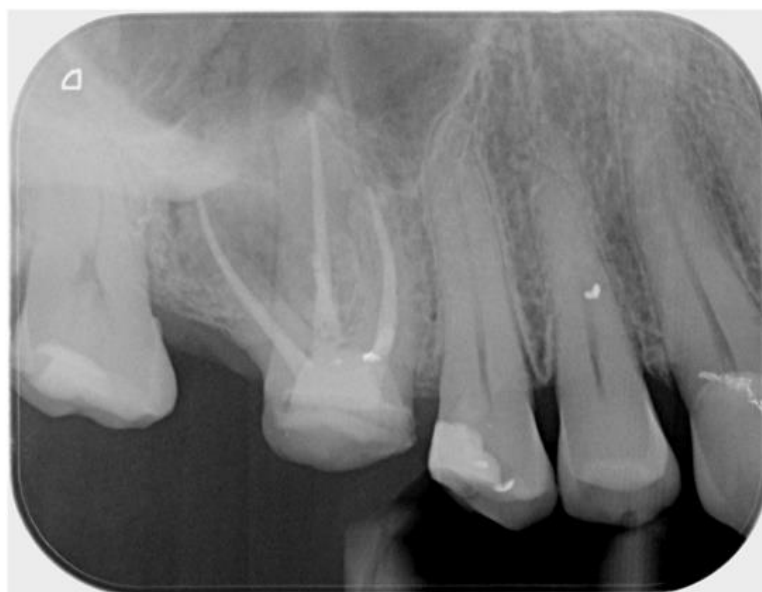
**Figure 11: Case 4. Post Operative x-ray showing a completed root canal treatment and a direct restoration**
