Prosthetic Management of Malpositioned Implant in RPD Case Report

Case Report

Keywords: Malpositioned Implants, Removable Partial Denture, Locator.

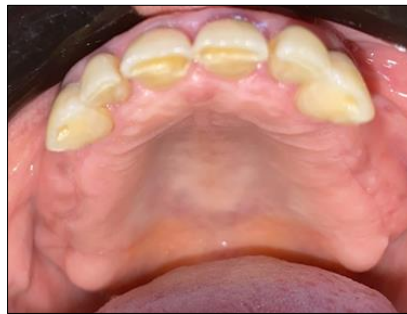
Fig. 2: Initial clinical situation

The intraoral examination showed: acceptable oral hygiene with presence in the maxillary of a bilateral free-end edentulism and attrition facets in the anterior teeth, the mandibular arch is practically toothed, only the absence of the 36 the right posterior sector was noted, the right posterior sector was restored by a hermetic metal ceramic bridge with abutment teeth 45 and 47. Fig 2,3,4

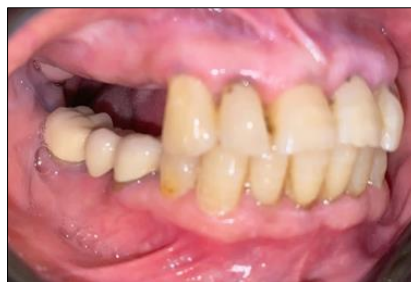
Fig. 3: Right view

The examination of the osteo-mucosal surfaces revealed edentulous ridges partially resorbed covered by adherent fibromucosa. Occlusal examination showed maintained DVO. Fig 3,4

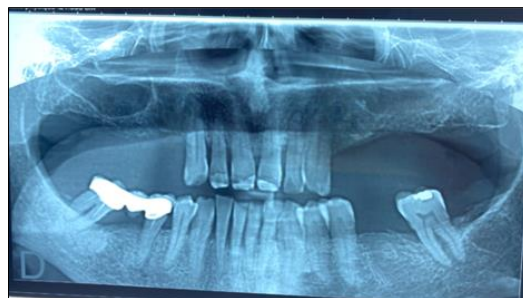
Fig. 5: Panoramic Radiography

Radiographic examination revealed a crown to root ratio (RC/RR), equal to 1 on the maxillary and mandibular anterior teeth with the exception of 46 which RC/RR > 1 also a dysplasia was noticed near to the mesial root 46. In the absence of infectious complications, the course of action is abstention and monitoring. Fig 5

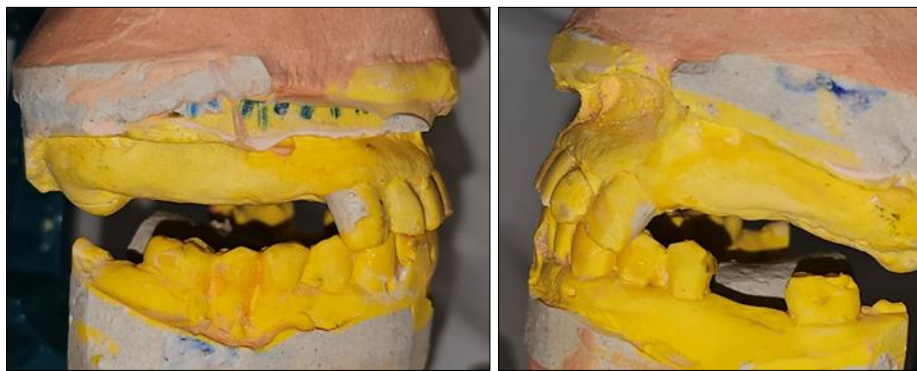
Fig. 7: Pre-prosthetic study

Pre-prosthetic study, removable partial prosthesis was proposed to the patient, who nevertheless wishes to avoid the visibility of metal clasp. Fig 7

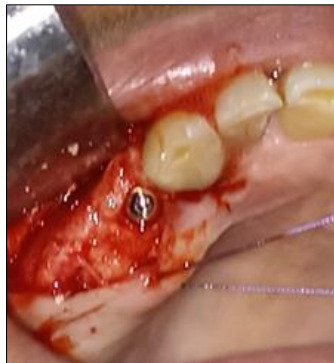
Fig. 8: Placement of 2 implants MODE® (4.1 Ø L 10) site 14 and 24

To provide stable occlusion, two 4.1 diameter implant with 10 mm in length (ref Mode[®]4.110) were placed distal to 13 and 23. Fig 8

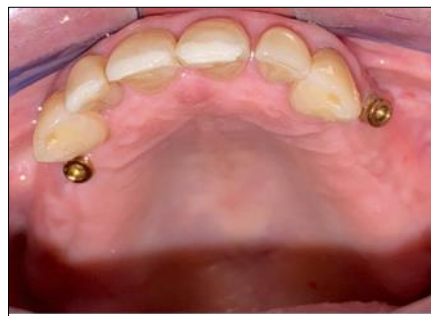
Fig. 9: Placement of Locator® healing abutments and tightening to 20 N/cm

Instead of the healing abutments, Locator Attachments were used during the initial delivery phase. Fig 9

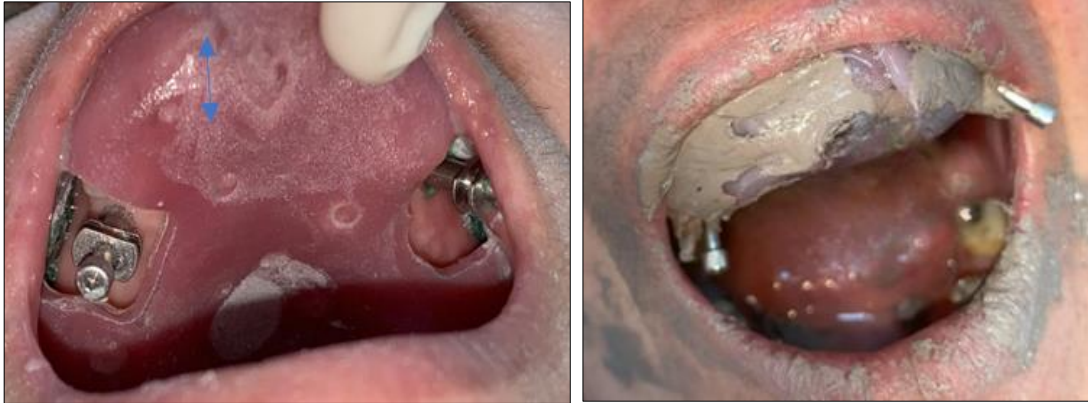
Fig. 10: Impression of preparations, implants' position and surfaces of bone and mucosa

A complete impression of the preparations and the implants' emergence using transfers made with individual trays (made on models from the primary impression) and a medium-viscosity polysulfide Permlastic[®]. Fig 10

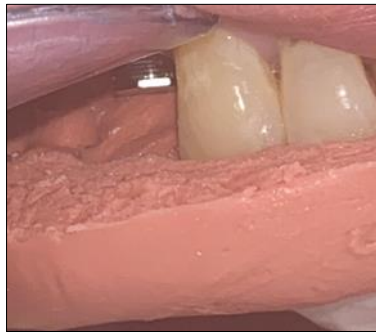
Fig. 11: Evaluation of the available vertical prosthetic space using silicone key

After casting, the metal copings with attachments are validated on the model using silicone keys and then in the mouth. Fig 11

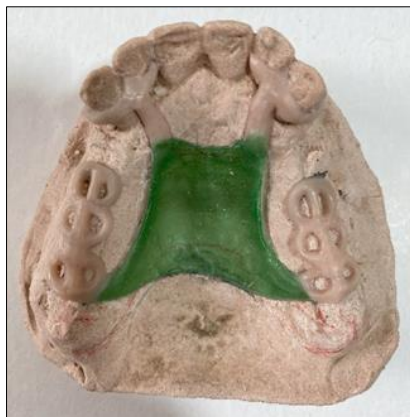
Fig. 12: The prosthetic project materialized by a pattern of the metal frame

To take into account the difference in depressibility of the support structure of the implant - stabilized RPD, we have chosen the stress breakers concept. Fig 12

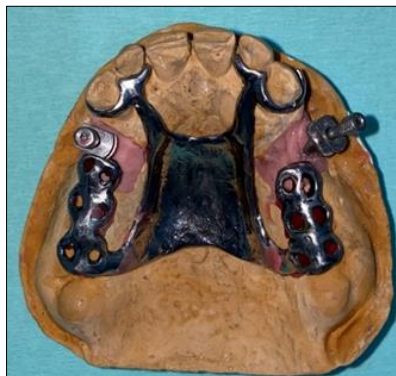
Subsequently, the metallic stellite will be poured onto the casting before being refined and smoothed then validating in mouth. Fig 13,14

Fig. 13: The saddles must be at a distance from the emergence of the implants to provide space dedicated to the connexion of the boxes

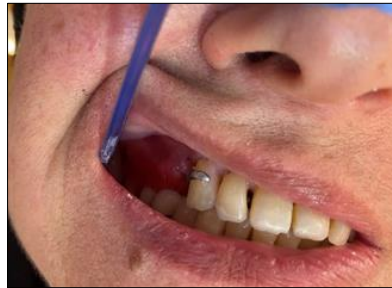
Fig. 15: Bite registration

After this step, two occlusion models are fabricated on the working models developed after the treatment of the impression, allowing the registration of the jaw relationship in centric relation and vertical dimension of the occlusion. Fig 15

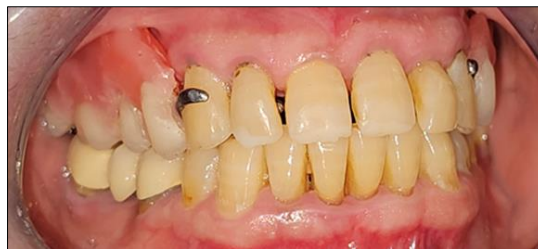
Fig. 16: Denture wax try-in

Later, a tooth mounting on wax is made. Fig 16

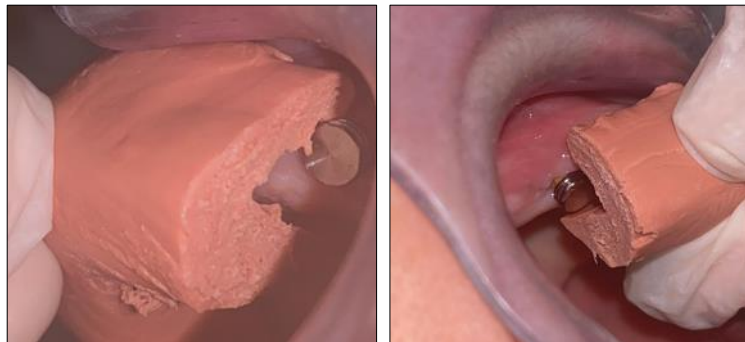
After the clinical, esthetic and functional tests and validation of the mounting wax, a key was made with a putty elastomeric to take the reference of the ideal profiles of the prosthetic extrados and anterior teeth. This key allows visualization of the prosthetic space available to incorporate the assembly of the complementary retention system without interfering with the ideal profile and lingual anterior teeth. Implant in site 23 remains in the prosthetic corridor but has a vestibuled position. Fig 17

Fig. 17: Vestibuled position of Implant in site 23, central position of implant in site 13

This present case report shows the importance of correct implant position under implant-stabilized RPD to avoid problems related to the lack of insertion, esthetic and retention problems. The standard Locator may be a solution to manage an implant disparallelism up to 40°. Unfortunately, in this report, this attachment interfered with the margin of denture preventing the insertion.

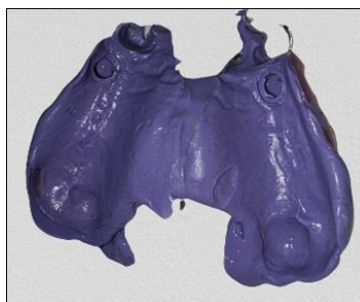
The removable prosthesis is placed in the mouth. During this step, the intrados of the maxillary prosthesis is recessed in front of the attachments. To assess complete insertion of denture excessive resin recess of the left prosthetic edge must be done that lead unfortunately to exposure of the left the metal housing. Fig 18,19

Fig. 18: Emptying interior surface base: use of a light silicone to specify areas that interfere with the Locator®'s box

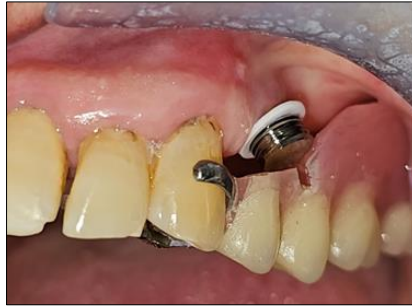
Fig. 19: Exposure of the left the metal housing after excessive resin recess

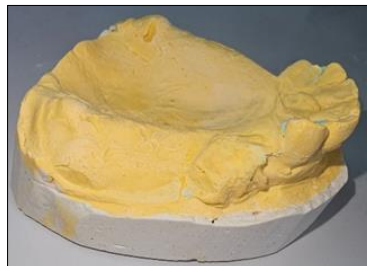
In laboratory, a discharge with the plaster next to the case then the prosthetic edge can be relined with auto-polymerizing resin. Fig 21

Fig. 21: Discharge with the plaster next to the case then casting the impression

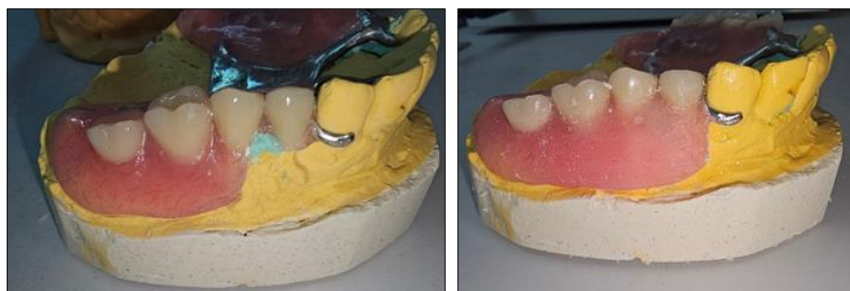
The spacers are in place and the female parts of the attachments (retaining sheaths in metal housings) are integrated into the prosthetic intrados using chemical curing resin under occlusal. Fig 22

Fig. 22: Relining the prosthetic edge with auto-polymerizing resin

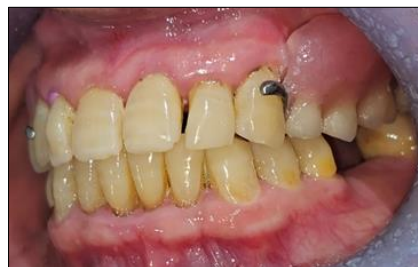
In order to optimize the aesthetic, clasps were grinded to the shoulders' and relined with resin Fig 23,24,25

Fig. 23: Connexion of the Patrice (black retention sheath) to the removable prosthesis under occlusion

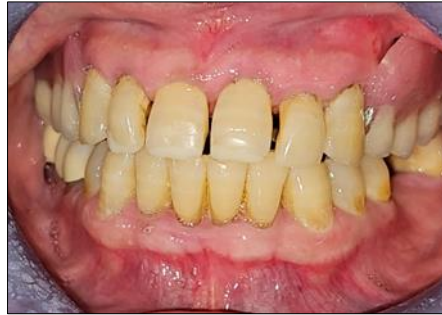
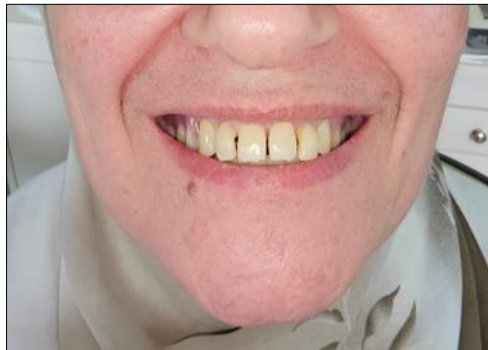
Fig. 24: Removal of clasps

Fig. 25: Improved aesthetic appearance after grinding the clasp's shoulder and relining with resin
