Central Venous Catheter Malposition into the Left Internal Mammary Vein in Patient with Coagulation Disorder and Safe Removal: A Case Report

Case Report

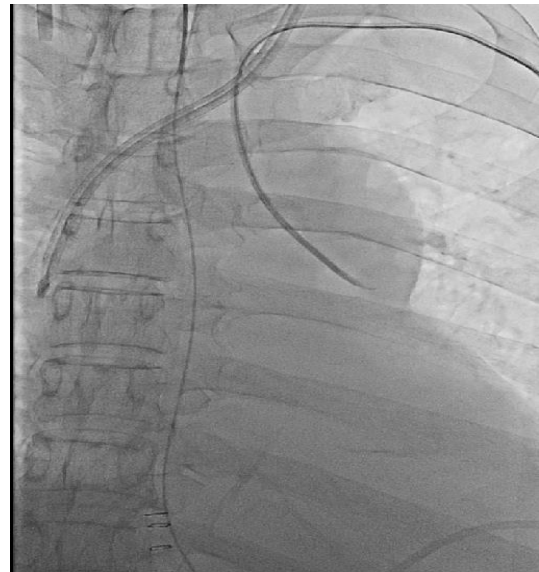
The postoperative chest image showed that the left SCV catheter was malpositioned (Fig 1). Through venography at the angiography room, it was confirmed that the CVC was inserted into the left IMV (Fig 2). The catheter was safely removed in cooperation with the radiologist (Fig 3).

Fig 1: Postoperative chest x-ray

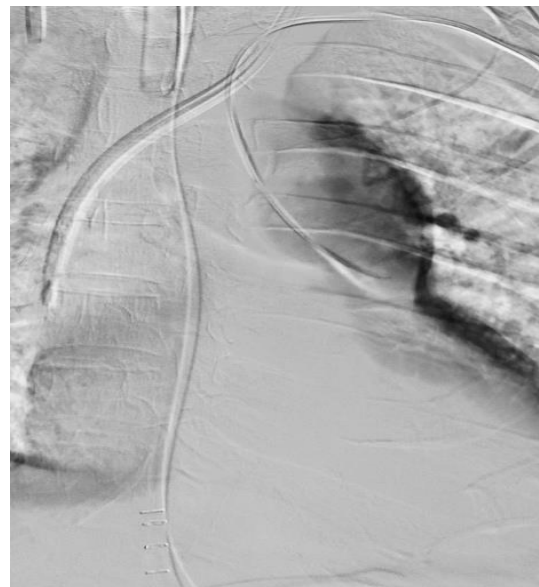
Fig 2: A venogram to confirm the catheter position

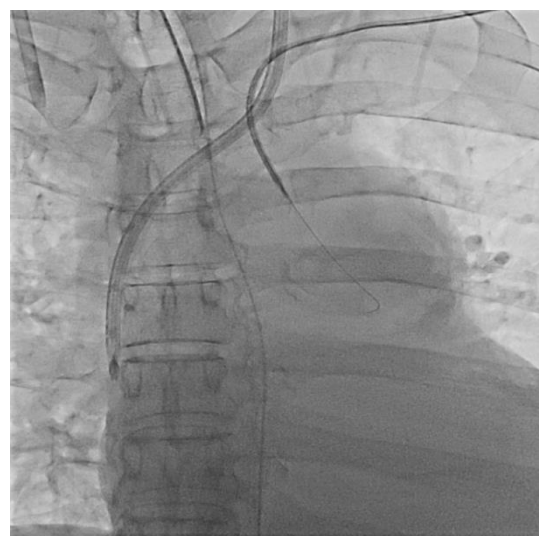
Fig 3: Catheter removal using angiography

Complications related to the placement of a CVC in the IMV include laceration of the IMV with massive hemothorax (Eulmesekian *et al.*, 2007) [8]. In order to prevent from occurring such a serious complication, it is recommended to remove the catheter under radiologic monitoring when the catheter was placed in the IMV (Wang *et al.*, 2016) [9]. In cooperation with the radiologist, the catheter was removed safely by venography.

Since this case was the patient with coagulation disorder (PT 48%, INR 1.69, and aPTT 53.2sec), special attention was required to remove the catheter. In addition, due to the location of the internal mammary vein, it was expected that it would be difficult to compress for hemostasis after removal of the catheter (Drewett, 2000) [10]. Therefore, it was necessary to check the patient's coagulation test to determine the appropriate time of the catheter removal. After liver transplantation, the PT level was prolonged until the post operative day (POD) 1, but decreased thereafter and maintained the normal range (11s-13s) from the POD 5. The aPTT was within the normal range (20s-35s) from POD 1 (Stahl *et al.*, 1990) [11]. Fibrin sheath begins to form on the catheter surface and vessel wall 24 hours after catheter placement, attaches the catheter to the vessel wall, making it difficult to remove, and forms a full-length sleeve in 5-7 days (Faintuch & Salazar, 2008) [12]. Therefore, we checked the patient's blood test results on the POD 3, which is considered to be the most appropriate time for PT/PTT values to approach to the normal level before the formation of the full-length sleeve fibrin sheath.
