Zonation Mapping Techniques of the Landslide Hazard in the Facet Area along NH 10 (Sevok to Tista Bazar) and Kalimpong-Lava-Garubathan Roads, Kalimpong District, Darjeeling Himalaya

Abstract: Kalimpong District in the Eastern Himalaya in West Bengal, India has been intensely destabilized by many landslides. Recently the incidence of landslide occurrence has increased rapidly with the gradual anthropogenic abuse of slopes specially the development of transport arteries and consequent jerk and vibration by vehicles. Due to landslides, the Darjeeling Himalayan region faces major problems of geoenvironmental imbalance and poses threats to life and property Therefore; landslide hazard zonation mapping becomes indispensable to identify the risk zone for future prevention and management of such hazards. With this view in mind, the present paper takes an attempt to undertake the work of landslide hazard zonation mapping of Kalimpong district, Darjeeling district.

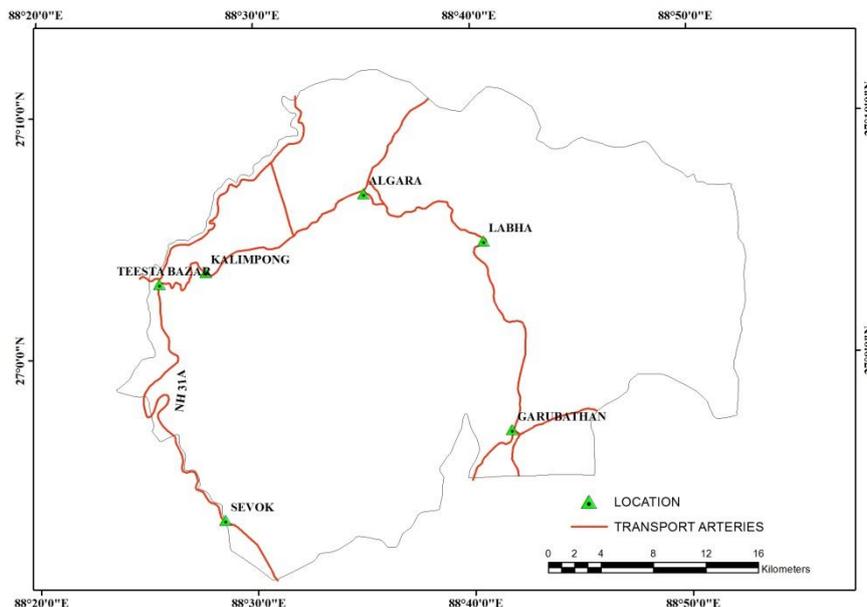
Fig-2: Main transport arteries of Kalimpong district

MAIN TRANSPORT ARTERIES OF KALIMPONG DISTRICT

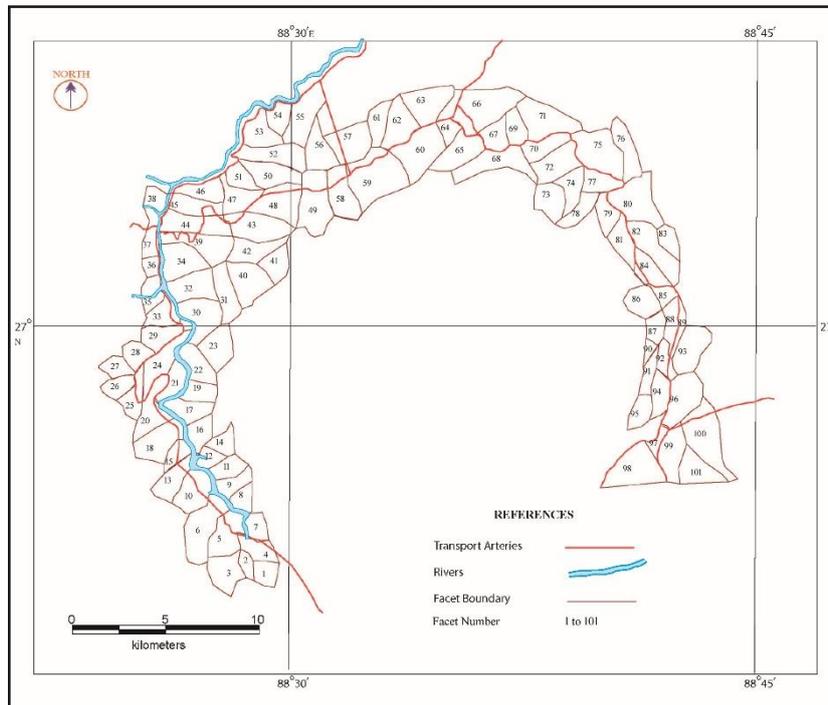
Fig-3: Facet map of the study area

FACET MAP OF THE STUDY AREA

Facet is a polygonal area of mountainous terrain, which has more or less similar characters of slope, showing consistent slope direction and inclination (Fig.2, 3 and 4). The slope facets are generally delimited by ridges breaks in slope, streams, spurs, gullies etc. The facet maps form the basis for the preparation of thematic maps in general and LHZ mapping in particular and individual facet is the smallest map able unit. In all 101 facets, including sub facets have been delineated from the study area based on visual interpretation of topographic maps.

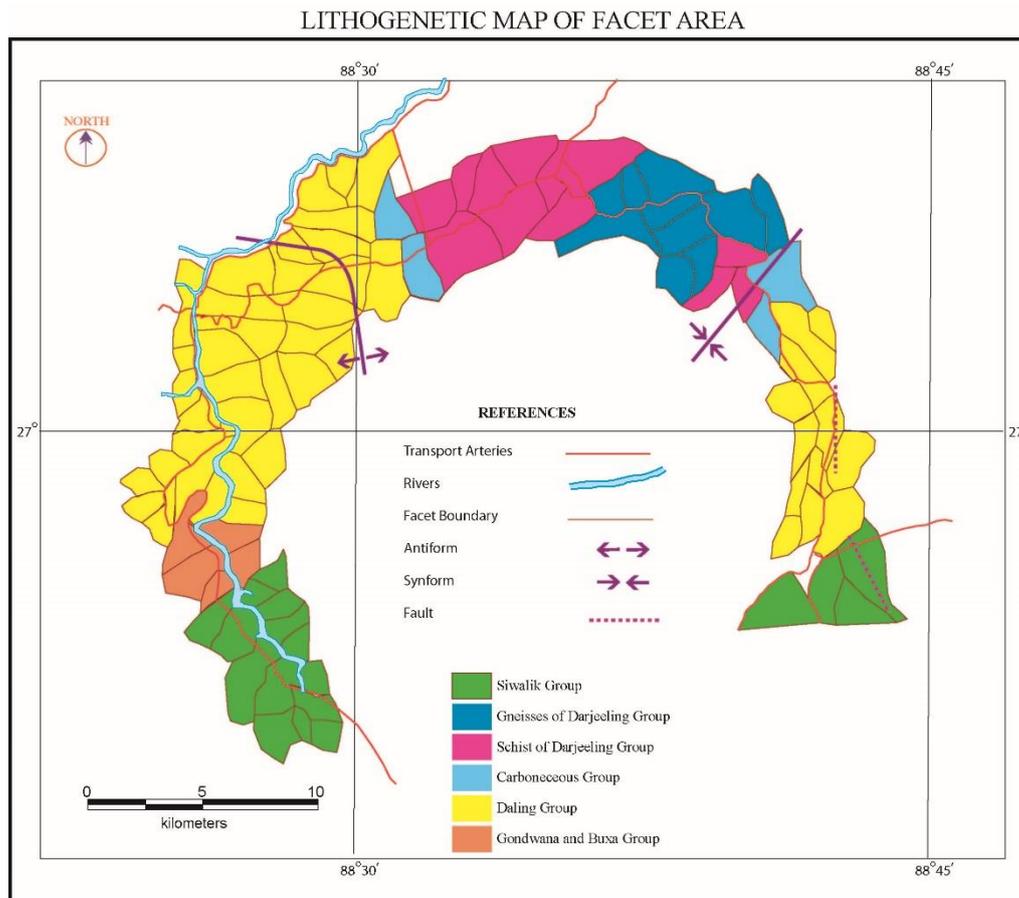
Fig-5: Lithological and structural condition of the facet area

rock composed of quartz, feldspar and biotite to more or less pure mica schist, and includes partly intrusive granite and partly metamorphosed beds of sedimentary origin. The Daling series covers a large area in the northeastern and western parts of the facet area. It consists of Phyllite, Gneiss and Schist.

The LHEF ratings of this group of rock are very high, that is 1.3 to 2.0. The Gondwana sedimentary beds crop out near the base of the hills and constitute with a narrow band between the Dalings and the Tertiaries. The Gondwana and Siwalik group of rock like shale, slates etc cover the southern portion of the study area and the LHEF rating of this group of rock ranges from 1.0 to 1.3 (Fig-5).

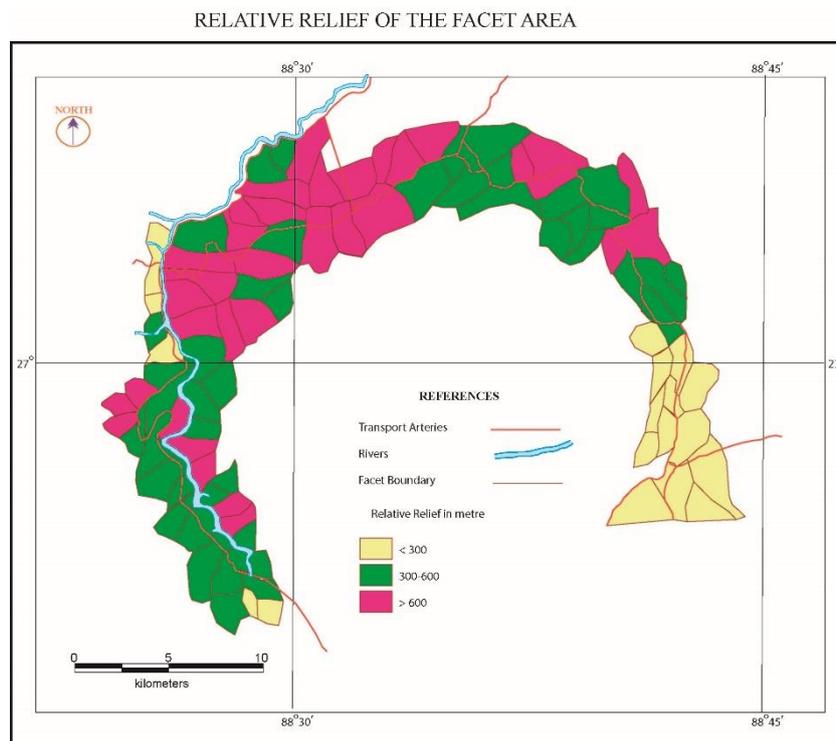
The relative relief of the study area is very high that the maximum portion of the study is >300 m.

Therefore, the LHEF rating of the entire area is 1.0 (Fig.-6).

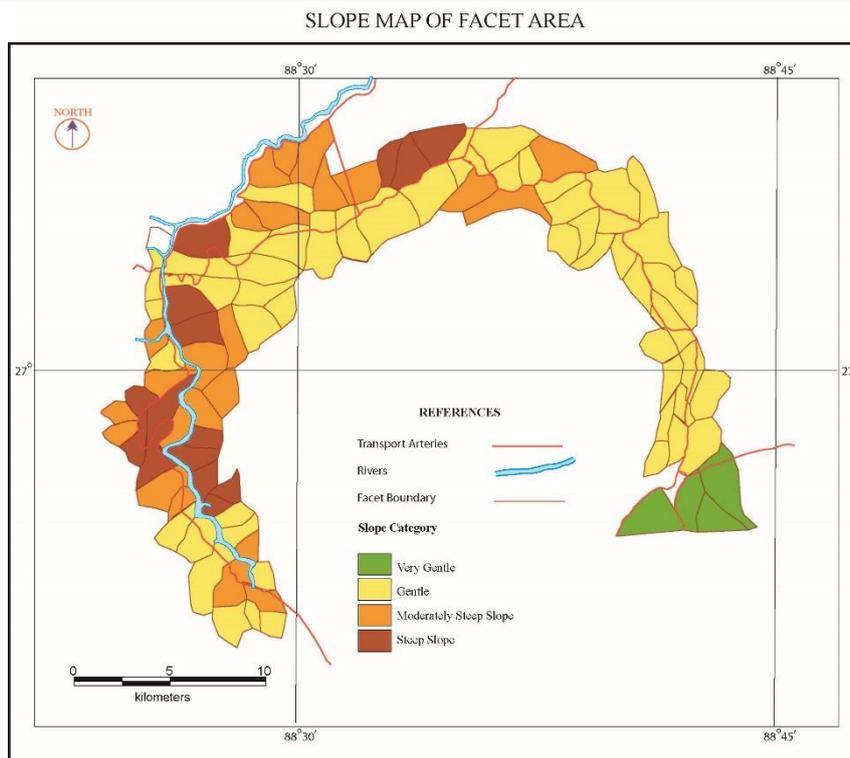
Fig-7: Slope map of the facet area

Five categories of slope morphometry such as escarpment / cliff slope, steep slope, moderately steep slope, gentle slope and very gentle slope are used depending on their slope angle in a particular facet. Since the slope angle is considered as an important geo-environmental parameter inducing slope instability.

LHEF value 2 (maximum) has assigned for it. Western portion along the Teesta River and the northern portion of the study area are characterized by moderate steep to steep slope (that is 26° to 45°), whereas the LHEF rating ranges from 1.2 to 1.7. Gentle slope (below 25°) occupied the Eastern and central portion of the study area, where the LHEF rating is 0.8 (Fig.-7).

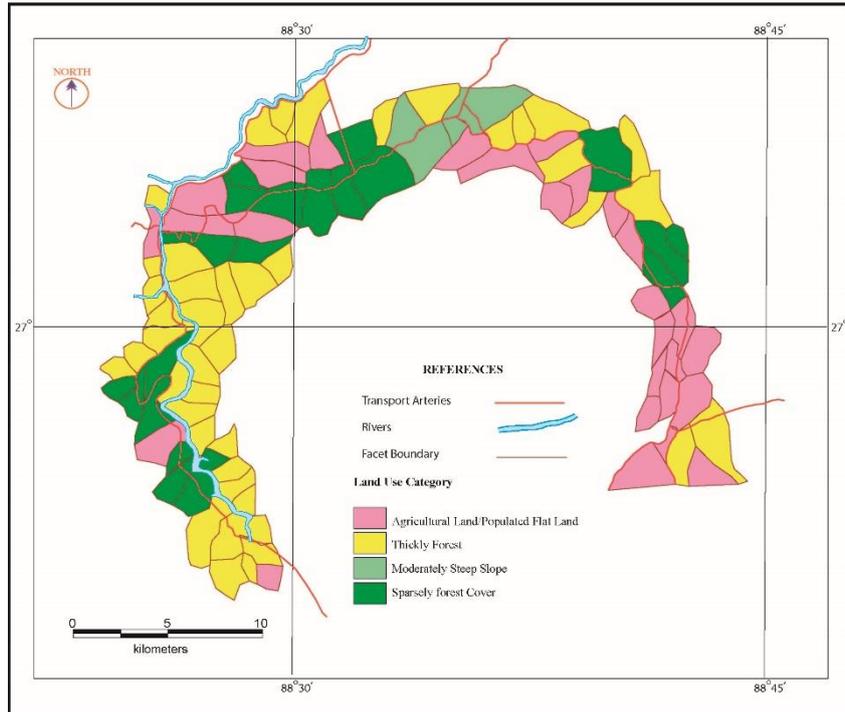
Fig-8: Land use map of the facet area

Barren. Land-use pattern is variable in this area. Thickly forest cover occupies in the western and northwestern portion of the study area, where the LHEF rating is 0.85. Agricultural land and populated flat land occupy the northwestern and eastern portion of the study area, where the LHEF rating is 0.6 and some pockets are covered by sparse forest of the study area and the LHEF rating of these portions is 1.5 (Fig-8).

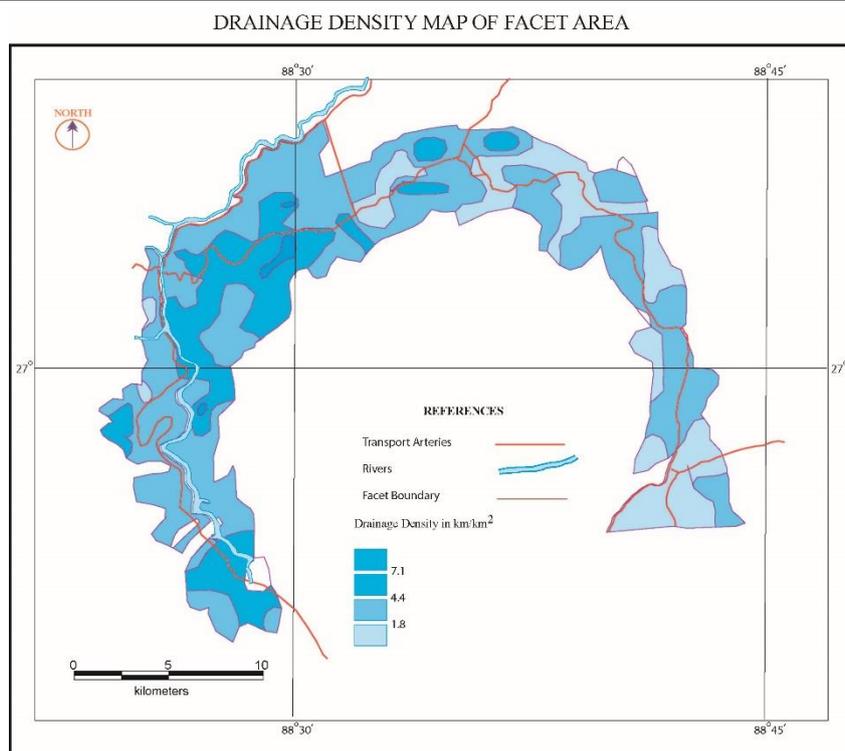
Fig-9: Drainage Density map of the facet area

Five categories of hydrological condition in LHEF rating scheme [4, 4] such as flowing, dripping, wet, damp and dry are used assigning with their

respective rating. The maximum portion of the facet area is wet so the LHEF rating is 0.5 and some pockets of the overall facet area is dripping condition whereas the LHEF rating is 0.8 (Fig-9).

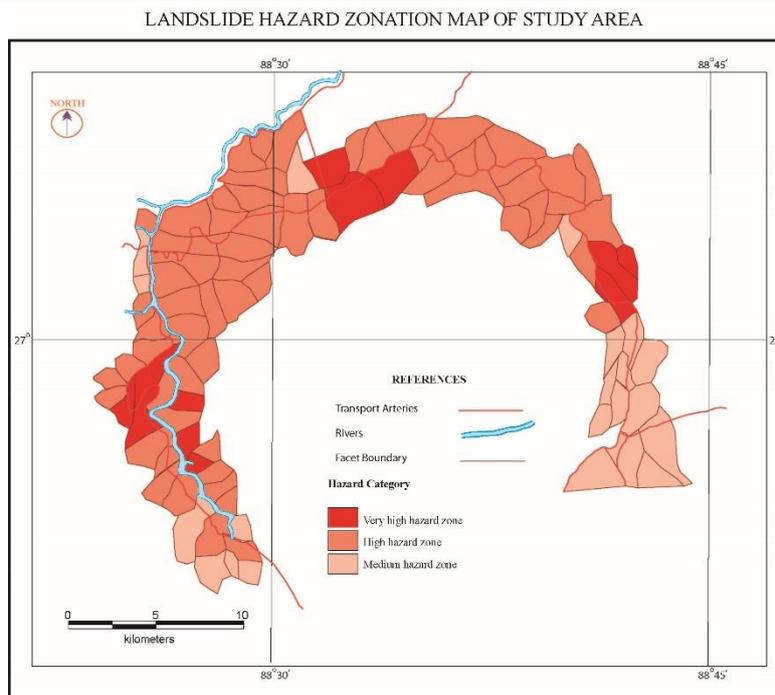
Landslide Hazard Zonation Map of the study area (Fig.10), it indicates that the maximum portion of the facet area (western, northern and northeastern) falls under high hazard zone, i.e. along the Teesta River (seвок to Teesta bazaar), Kalimpong town area, and Kalimpong Algara- Labha sector. Kalijhora, Swetijhra, Algara and Labha spot of the facet area are characterized by Very high hazard zone. Southwestern and southeastern (Garubathan) portions of the study area fall under medium hazard zone.

Based on SOI Toposheet Map No 78A/8, 78A/12, 78B/5 & 78B/9., LAND SAT IMAGE, GSI Map, Natmo Map and other Govt. agencies.
