Aesthetic Rehabilitation of Anterior Fractured Teeth with Partial Veneer: A Case Report

Abstract**Case Report**

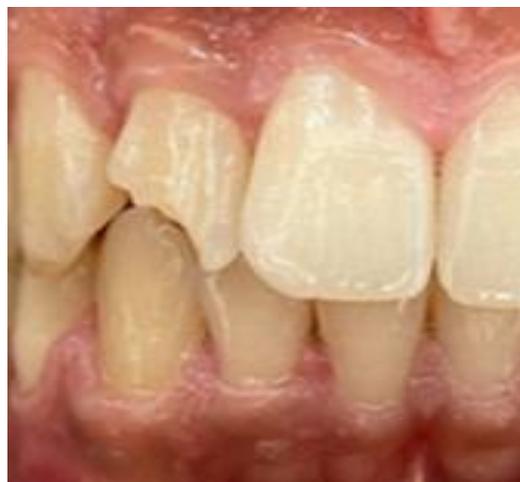
Figure 1: Labial view of the teeth in static occlusion

Before the restorative procedure, intraoral photographs were taken to analyze the cosmetic aspects of the case (Figure 1). The preparation consisted in rounding and smoothing all the internal surface (Figure 2). The provisional restoration was performed using waxed-up model and a bis-acryl provisional material (Dentocrown HD, ITENA, France) (Figure 3). A double silicone impression was made (Protesil, VANNINI, Italie). Then, the restoration was fabricated with feldspathic ceramic using the layering technique (figure 4-5). Before adhesive cementation, the restoration was evaluated clinically in terms of marginal adaptation and aesthetic result. As for the bonding resin, a transparent dual-cure one was selected (Variolink N, IVOCLAR, Switzerland). The following step was the application of a 9% hydrofluoric acid (Ceram-Etch, ITENA, France) on the inner side of partial veneer for 120 seconds. The restoration was washed in running water for 60 seconds, then a coupling agent: silane (Monobond N, IVOCLAR, Switzerland) was applied for 1 minute (Figure 6). As for the surface tooth, a partially sectioned rubber dam was performed to ensure perfect isolation (Figure 7). A selective etching was performed using a 37% orthophosphoric acid (Total Etch, IVOCLAR, Switzerland) (Figure 8). The acid was applied to the enamel for 30 seconds and to the dentin for 15 seconds. Then, dental surface was washed with water and slightly dried. The adhesive (Syntax Primer and Syntax Adhesive, IVOCLAR, Switzerland) was applied to the tooth by the mean of a micro brush and then dried with a gentle blast of air (Figure 9). The light-curing was not applied to avoid inaccuracies of fit. The resin cement (Variolink N, IVOCLAR, Switzerland) was placed on the inner side of the prosthetic piece and then light cured for five seconds (Figure 10). A micro brush was used to remove excess luting material (figure 11) and the restoration margin was covered with a film of glycerin to protect the final light curing of the bonding

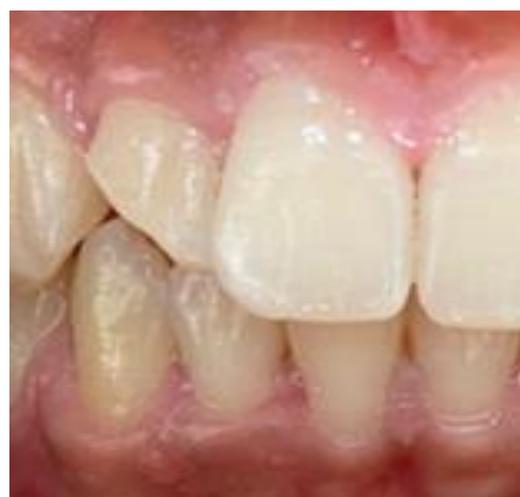
Figure 2: Labial view after minimal preparation by rounding the internal surface

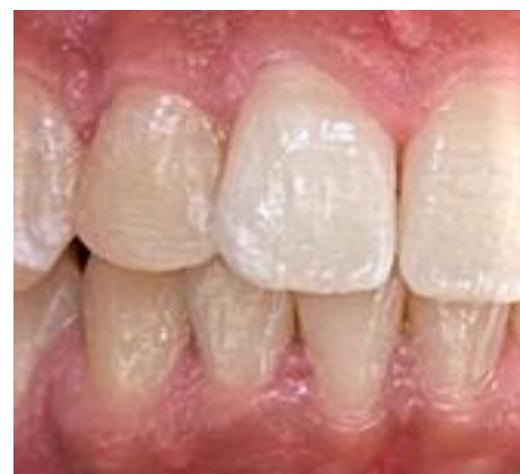
Figure 3: Provisional restoration

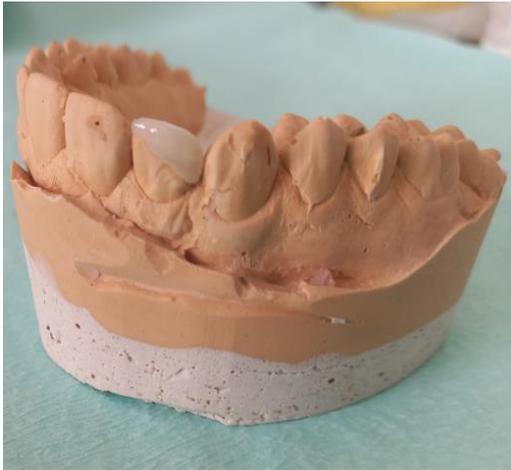
Figure 4: Partial veneer on the cast

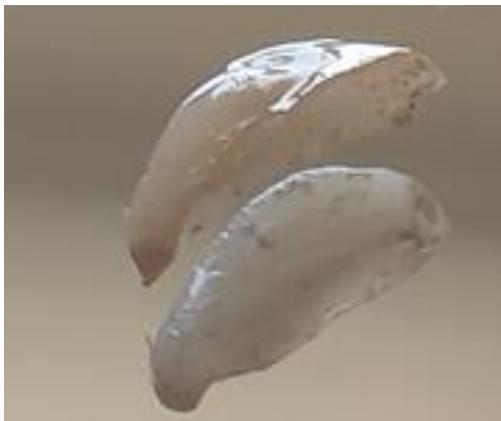
Figure 5: Ceramic partial veneer

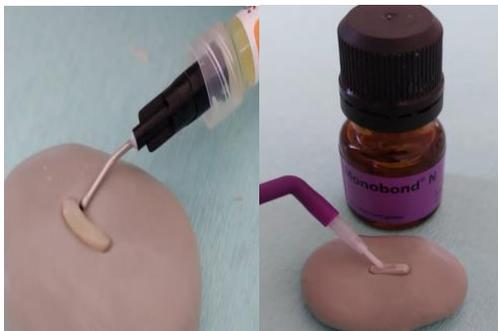
Figure 6: Surface treatment of the partial veneer: Application of hydrofluoric acid etching and silane application

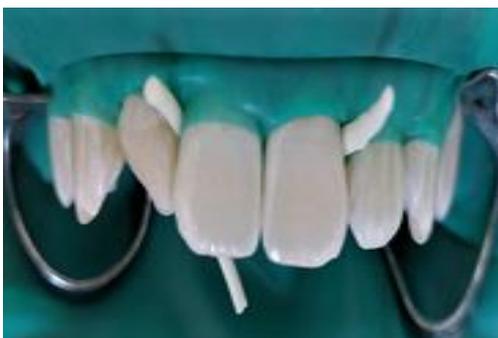
Figure 7: Isolation of the teeth using a rubber dam

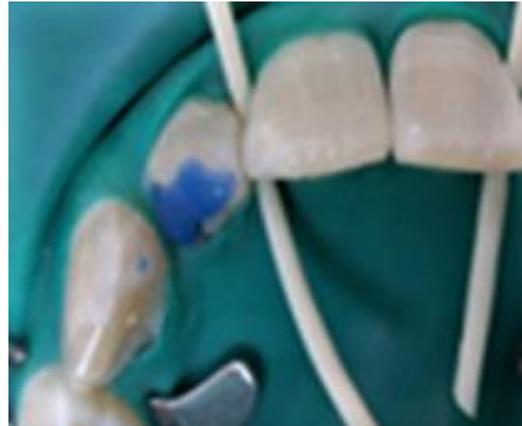
Figure 8: Application of the etching agent

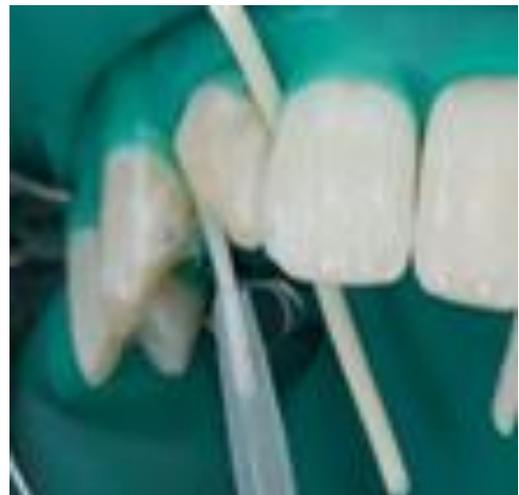
Figure 9: Application of the bonding Agent

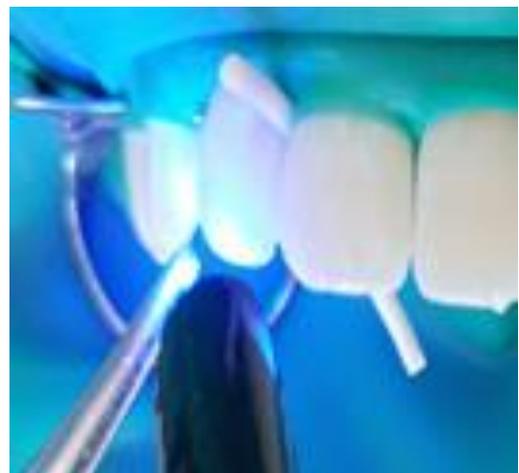
Figure 10: Light curing after sectional veneer placement

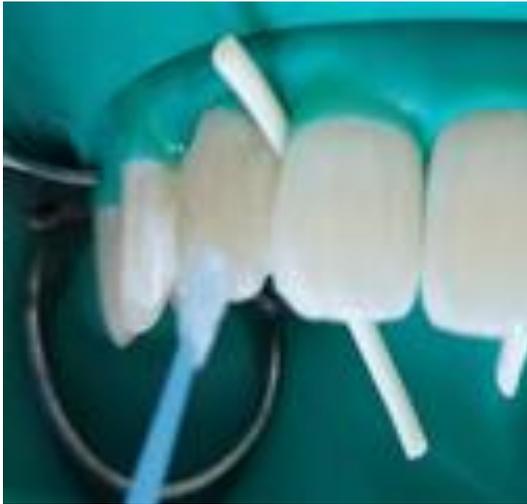
Figure 11: Excess resin removing

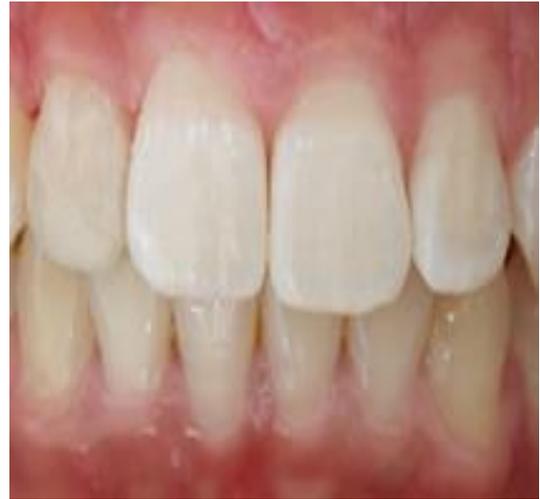
Figure 14: Labial view of the final result

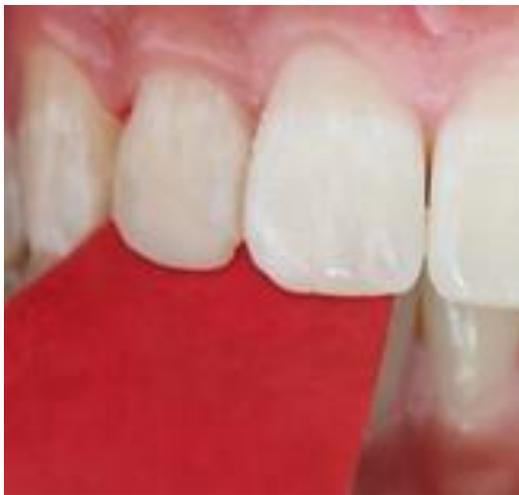
Figure 12: Occlusal adjustment

seal from exposure to oxygen (Liquid Strip, IVICLAR, Switzerland). After that, the curing cycle was finished for 60 seconds each surface. Finally, static and dynamic occlusion were controlled (Figure 12) and all the limits were delicately polished to ensure a smooth and luster surface (Figure 13).

Careful attention should be required to the evaluation of the occlusion. The centric occlusal contact shouldn't fall on the interface between restoration and enamel. So, the finish line should be placed either before the contact in the enamel tissue, or after leaving it in ceramic [8]. After cementation, the occlusal adjustment is very important, not only in centric but mostly in protrusive movement. A poor adjustment can increase the chance of chipping or debonding [8].

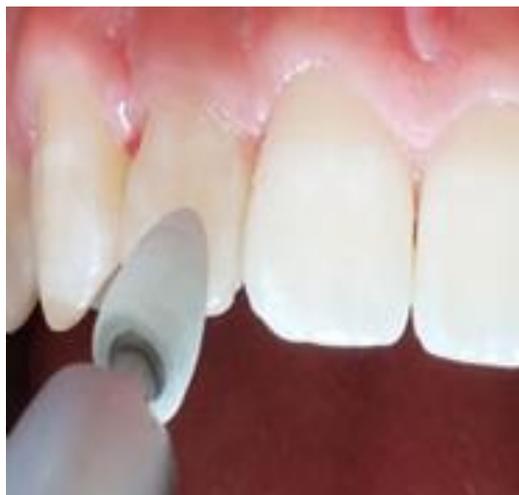
Figure 13: Finishing and polishing procedure
