Skin and Subcutaneous Injuries with Peroneus Nerve Paralysis Induced By Suction from a Drain in a Hot Spring

Abstract: A 48-year-old obese woman with hypertension stayed at a hot springs inn while on vacation. When she sat near the uncovered drain at the entrance to the spring's filtration system, her left thigh became sucked and trapped by the drain, and she was unable to escape on her own. The rescuers were able to successfully pull her out and transported her to the hospital. On arrival, she had left subcutaneous hemorrhaging with multiple small blisters on the left thigh with severe pain and left peroneus nerve paralysis. The patient was treated by conservative therapy and then transferred to the local hospital near her home. To our knowledge, this is the first case of skin and subcutaneous injuries with peroneal nerve paralysis induced by suction from a drain in a hot spring. The patient's thigh was so large it completely covered the drain at the entrance to the filtration system. In addition, the owner of the spring had neglected to install a grilled cover over the hole, so the suction power was increased. These two elements resulted in a rare case of suction injury.

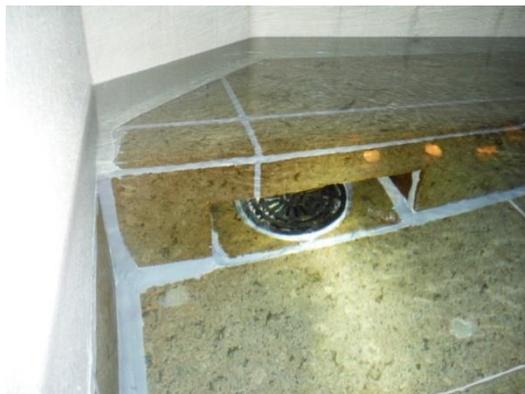
Fig-1: Covered drain at the entrance to the spring's filtration system. The patient's left thigh became sucked and trapped by the uncovered drain

A 48-year-old obese woman with hypertension stayed at a hot springs inn while on vacation. When she sat near the uncovered drain at the entrance to the spring's filtration system, her left thigh became sucked and trapped by the drain (Figure 1). She was unable to escape on her own, so she sought help from nearby guests in the hot springs room. Rescuers initially stopped the filtration system and then tried to drain the water from the bath and were ultimately able to successfully pull her out, transporting her to our hospital.

Both of the non-Japanese reports described cases of gluteal and hand injuries due to exposure to an unsecured drainage hole at the entrance to the filtration system in a swimming pool [1,2]. The intake of a pool's filtration system may generate sufficient negative pressure to induce acute soft tissue injuries, including compartment syndrome of the interosseous muscles, requiring acute surgical decompression. Inagaki *et al.* reported that the negative suction power generated by the filtration system in a pool was 1kg/cm². [5] In Japan, a girl in second grade of primary school died after being sucked through an uncovered suction hole at the entrance to the filtration system at the Fujimino Public Pool on July 31, 2006. In the present case, patient's thigh was so large it completely covered the drain at the entrance to the filtration system. In addition, the owner of the spring had neglected to install a grilled cover over the hole, so the suction power was increased. These two elements resulted in a rare case of suction injury. The localized and often bizarre, large swellings and suffusions associated with such injury can be treated nonoperatively in the vast majority of cases, similar to the present case[2].

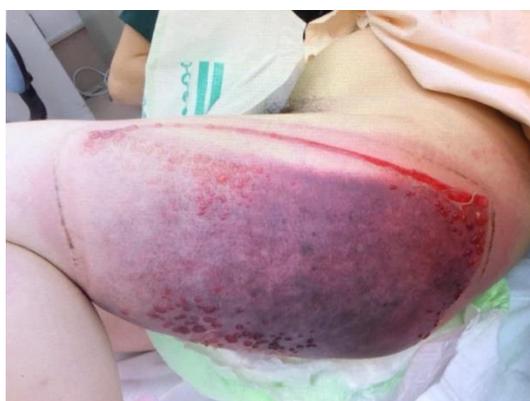
Fig-2: Visual findings on arrival

The patient had left subcutaneous hemorrhaging with multiple small blisters on the left thigh.

respiratory rate of 20/minute, an oxygen saturation of 98% under room air, and an axillary temperature of 38.9 °C. She had left subcutaneous hemorrhaging with multiple small blisters on the left thigh with severe pain (Figure 2) and left peroneus nerve paralysis. The main results of a biochemical analysis of the blood were only leukocytosis (11,400/ μ l). She received conservative therapy for the left thigh lesions and paralysis. Magnetic resonance imaging on the third hospital day showed only subcutaneous edema without muscle lesions (Figure 3). On the fifth day, she was transferred to a local hospital near her home, and while the pain in her thigh had improved, the peroneal nerve paralysis had not improved.

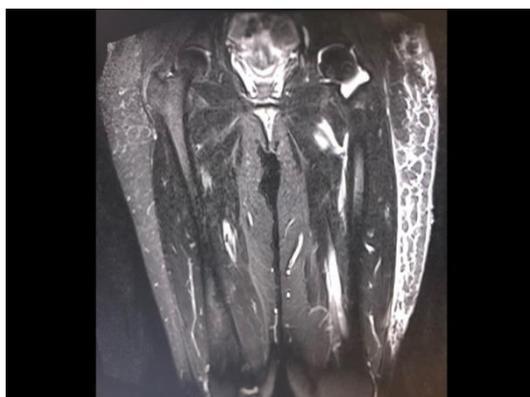
Fig-3: Magnetic resonance imaging (MRI) on the third hospital day

MRI showed only subcutaneous edema without muscle lesions.
